Access Compliance Report

Public Rights-of-Way

(Curb Ramps)

Intersection ID: 30550	Main Street: ARBORETUM SHOPPING CENTER DR	Side Street: PROVIDENCE RD	Location: NW
ADA ID: BA1211B86800	Ramp Type: PerpDiag	Initial Pass/Fail: Fail	Overall Compliance: No
Severity Score: 22.5			
Codes/Mitigation Info/Possible Solution		Field Measurements/Component Compliance

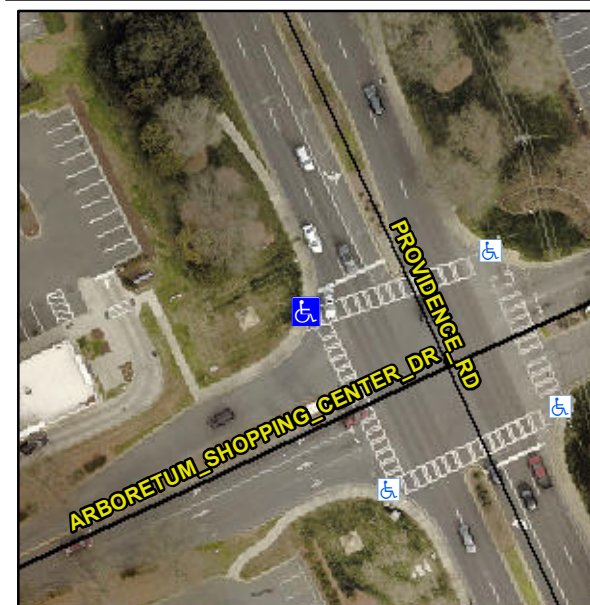
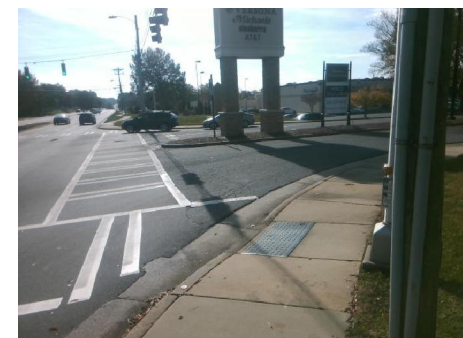
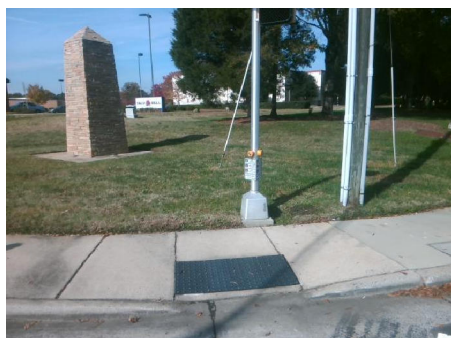
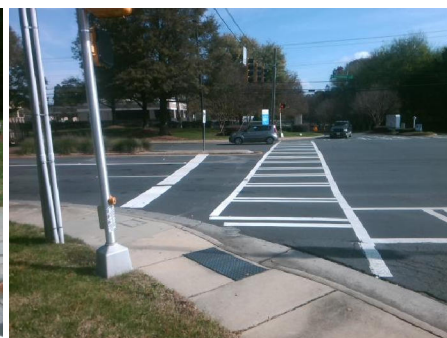
Not Found, R304.5.1, R304.2.2

Compliance	Description	Data	Compliance	Description	Data
N/A	Ramp Length (in)	60.0	No	Ramp Slope (%)	10.0
No	Ramp Width (in)	46.0	Yes	Ramp XSlope (%)	2.5
N/A	Flare Type LT	N/A	N/A	Flare Type RT	N/A
N/A	Flare Slope LT (%)	N/A	N/A	Flare Slope RT (%)	N/A
N/A	Flare Traversable LT?	N/A	N/A	Flare Traversable RT?	N/A
N/A	Landing Length (in)	N/A	N/A	DWS Provided?	N/A
N/A	Landing Width (in)	N/A	N/A	DWS Contrast?	N/A
N/A	Landing Slope (%)	N/A	N/A	DWS Length (in)	N/A
N/A	Landing X Slope (%)	N/A	N/A	DWS Full Width?	N/A
N/A	Landing Curb? (Y/N)	N/A	N/A	DWS Offset (in)	N/A
N/A	Shared Landing?	N/A			
N/A	Gutter Ponding?	N/A	N/A	Gutter Slope (%)	N/A
N/A	Gutter Lip Ht (in)	N/A	N/A	Gutter X Slope (%)	N/A
N/A	Painted X Walk1?	Yes	N/A	Painted X Walk2?	Yes
	X Walk 1 Direction	To SE		X Walk 2 Direction	To NE
N/A	X Walk 1 Width (in)	84.0	N/A	X Walk 2 Width (in)	107.0
	X Walk 1 Slope (%)	1.2		X Walk 2 Slope (%)	5.5
	X Walk 1 X Slope (%)	4.0		X Walk 2 X Slope (%)	1.8

N/A	Ramp inside XWalk1?	Yes	N/A	Ramp inside XWalk2?	No
	Road Slope (%)	2.5	N/A	Clear Space?	N/A
	Road X Slope (%)	2.9	N/A	Clear Space to XWalk (in)	N/A
N/A	Any Obstructions?	N/A	N/A	Storm Grate/Utility Hazard?	N/A
	Obstruction Type			Storm Grate/Utility Type	
		N/A			N/A
			Yes	Surface Condition? (G/P)	Good

Remove & Replace Curb Ramp With Two New Directional Ramps or Equivalent. Restripe Crosswalk.
