# Access Compliance Report

## Public Rights-of-Way

| Intersection ID: 14405 | Main Street: KENMORE_AV | Cross Street: OSBORNE_AV | Location: S |
| ADA ID: BA179AB16AA4 | Ramp Type: BlendTrans1 | Initial Pass/Fail: Fail | Overall Compliance: No |

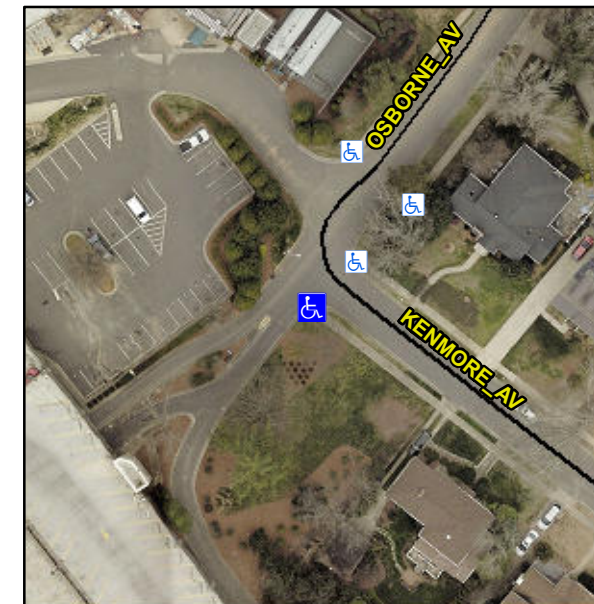
| | | Severity Score: 1.25 | |

**Not Found, R304.5.3**

| Compliance | Description | Data | Compliance | Description | Data |
|---|---|---|---|---|---|
| Yes | Ramp Width (in) | 48.0 | No | BlendTrans XSlope (%) | 4.4 |
| | | | No | Curb Slope (%) | 8.7 |

**Remove & Replace Curb Ramp With Two New Directional Ramps or Equivalent.**

Total Cost: \$ 3200.00
