Access Compliance Report

Public Rights-of-Way

(Curb Ramps)

Intersection ID: 12086	Main Street: CAMP_GREENE_ST	Cross Street: MARLOWE_AV	Location: SE
ADA ID: BA22924A7B1D	Ramp Type: Perp	Initial Pass/Fail: Fail	Overall Compliance: No
		Severity Score: 22.5

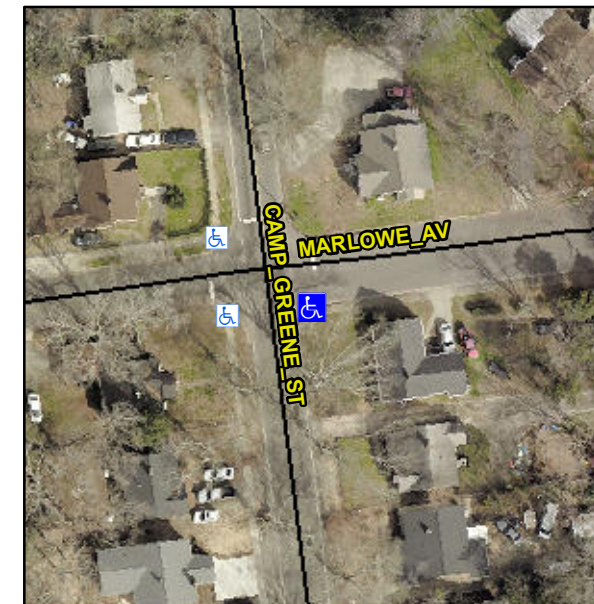
Not Found, R304.5.1, R304.2.2, R304.5.3

Compliance	Description	Data	Compliance	Description	Data
N/A	Ramp Length (in)	58.5	No	Ramp Slope (%)	8.8
No	Ramp Width (in)	47.5	No	Ramp XSlope (%)	3.2
N/A	Flare Type LT	N/A	N/A	Flare Type RT	N/A
N/A	Flare Slope LT (%)	N/A	N/A	Flare Slope RT (%)	N/A
N/A	Flare Traversable LT?	N/A	N/A	Flare Traversable RT?	N/A
N/A	Landing Length (in)	N/A	N/A	DWS Provided?	N/A
N/A	Landing Width (in)	N/A	N/A	DWS Contrast?	N/A
N/A	Landing Slope (%)	N/A	N/A	DWS Length (in)	N/A
N/A	Landing X Slope (%)	N/A	N/A	DWS Full Width?	N/A
N/A	Landing Curb? (Y/N)	N/A	N/A	DWS Offset (in)	N/A
N/A	Shared Landing?	N/A			
N/A	Gutter Ponding?	N/A	N/A	Gutter Slope (%)	N/A
N/A	Gutter Lip Ht (in)	N/A	N/A	Gutter X Slope (%)	N/A
N/A	Painted X Walk1?	No	N/A	Painted X Walk2?	N/A
	X Walk 1 Direction	To W		X Walk 2 Direction	N/A
N/A	X Walk 1 Width (in)	N/A	N/A	X Walk 2 Width (in)	N/A
	X Walk 1 Slope (%)	3.6		X Walk 2 Slope (%)	N/A
	X Walk 1 X Slope (%)	2.8		X Walk 2 X Slope (%)	N/A

N/A	Ramp inside XWalk1?	N/A	N/A	Ramp inside XWalk2?	N/A
	Road Slope (%)	N/A	N/A	Clear Space?	N/A
	Road X Slope (%)	N/A	N/A	Clear Space to XWalk (in)	N/A
N/A	Any Obstructions?	N/A	N/A	Storm Grate/Utility Hazard?	N/A
	Obstruction Type			Storm Grate/Utility Type	
		N/A			N/A
			Yes	Surface Condition? (G/P)	Good

Remove & Replace Entire Ramp.
