Access Compliance Report

Public Rights-of-Way

(Curb Ramps)

Intersection ID: 8462	Main Street: ROLLING_HILL_DR	Cross Street: W_SUGAR_CREEK_RD	Location: SE
ADA ID: BA25565FFD05	Ramp Type: ParaDiag	Initial Pass/Fail: Pass	Overall Compliance: No
Severity Score: 0.25			
Codes/Mitigation Info/Possible Solution		Field Measurements/Component Compliance

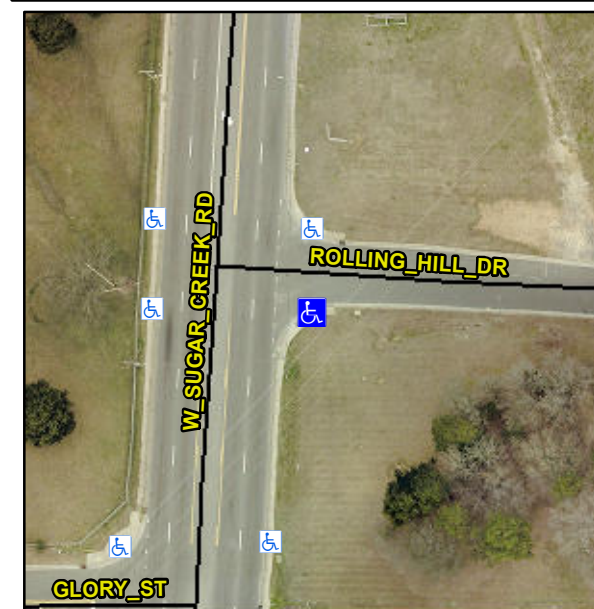
RT RP < 5%

Compliance	Description	Data	Compliance	Description	Data
N/A	Ramp Length LT (in)	56.0	N/A	Ramp Length RT (in)	60.0
Yes	Ramp Width LT (in)	49.0	Yes	Ramp Width RT (in)	53.0
Yes	Ramp Slope LT (%)	7.7	Yes	Ramp Slope RT (%)	4.3
No	Ramp XSlope LT (%)	2.6	Yes	Ramp XSlope RT (%)	1.1
Yes	Landing Length (in)	60.0	Yes	DWS Provided?	Yes
Yes	Landing Width (in)	48.0	Yes	DWS Contrast?	Yes
Yes	Landing Slope (%)	1.8	Yes	DWS Length (in)	24.5
Yes	Landing X Slope (%)	0.8	Yes	DWS Full Width?	Yes
N/A	Landing Curb? (Y/N)	No	Yes	DWS Offset (in)	0.0
N/A	Shared Landing?	No			
No	Gutter Ponding?	Yes	Yes	Gutter Slope (%)	0.9
Yes	Gutter Lip Ht (in)	0.0	Yes	Gutter X Slope (%)	1.3
N/A	Painted X Walk1?	No	N/A	Painted X Walk2?	No
	X Walk 1 Direction	To N		X Walk 2 Direction	To W
N/A	X Walk 1 Width (in)	N/A	N/A	X Walk 2 Width (in)	N/A
	X Walk 1 Slope (%)	2.8		X Walk 2 Slope (%)	1.0
	X Walk 1 X Slope (%)	0.0		X Walk 2 X Slope (%)	1.7
N/A	Ramp inside XWalk1?	N/A	N/A	Ramp inside XWalk2?	N/A

Road Slope (%)	2.1	N/A	Clear Space?	Yes
	Road X Slope (%)	1.7	N/A	Clear Space to XWalk (in)	N/A
Yes	Any Obstructions?	No	Yes	Storm Grate/Utility Hazard?	No
	Obstruction Type			Storm Grate/Utility Type	
		N/A			N/A
			Yes	Surface Condition? (G/P)	Good
			N/A	Curb Slope (%)	26.4

Possible Solutions:

Remove & Replace Curb Ramp With Two New Directional Ramps or Equivalent. Gutter Ponding Observed.

R304.5.3, R302.7
