Access Compliance Report

Public Rights-of-Way

(Curb Ramps)

| Intersection ID: 13660 | Main Street: BRENTWOOD_PL | Cross Street: REMOUNT_RD | Location: NE |

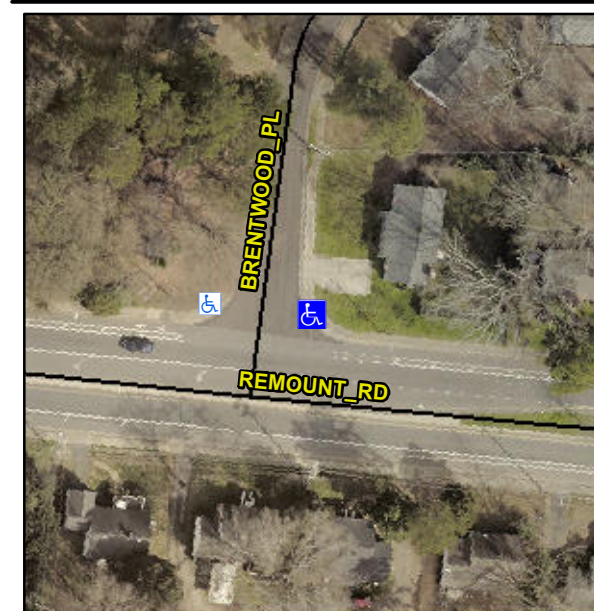
Not Found, R304.5.1, R304.5.3

| Compliance | Description | Data | Compliance | Description | Data |
|---|---|---|---|---|---|
| N/A | Ramp Length (in) | 58.0 | Yes | Ramp Slope (%) | 7.7 |
| No | Ramp Width (in) | 36.0 | No | Ramp XSlope (%) | 5.2 |

Remove & Replace Curb Ramp With Two New Directional Ramps or Equivalent.
