Access Compliance Report

Public Rights-of-Way

(Curb Ramps)

Intersection ID: 51314	Main Street: W_W_T_HARRIS_BV	Cross Street: I-485_RA	Location: SW
ADA ID: BA3B1F13DFE9	Ramp Type: Perp	Initial Pass/Fail: Fail	Overall Compliance: No
Severity Score: 22.5			
Codes/Mitigation Info/Possible Solution		Field Measurements/Component Compliance

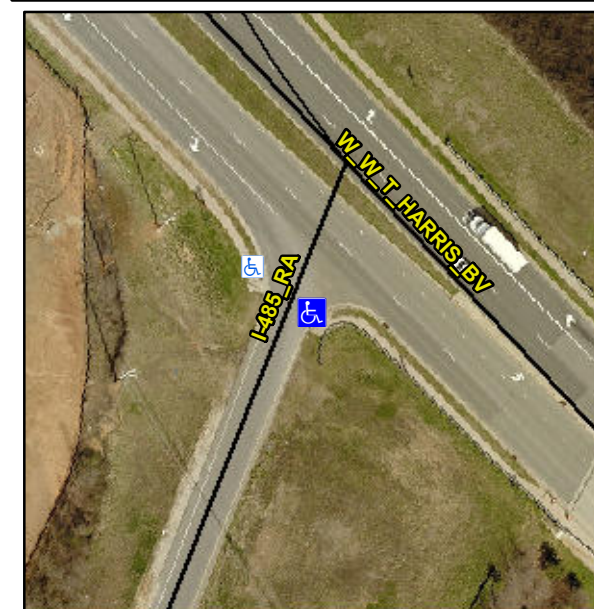
Not Found, R304.5.1, R304.2.2

Compliance	Description	Data	Compliance	Description	Data
N/A	Ramp Length (in)	88.0	No	Ramp Slope (%)	8.6
No	Ramp Width (in)	46.5	Yes	Ramp XSlope (%)	2.1
N/A	Flare Type LT	N/A	N/A	Flare Type RT	N/A
N/A	Flare Slope LT (%)	N/A	N/A	Flare Slope RT (%)	N/A
N/A	Flare Traversable LT?	N/A	N/A	Flare Traversable RT?	N/A
N/A	Landing Length (in)	N/A	N/A	DWS Provided?	N/A
N/A	Landing Width (in)	N/A	N/A	DWS Contrast?	N/A
N/A	Landing Slope (%)	N/A	N/A	DWS Length (in)	N/A
N/A	Landing X Slope (%)	N/A	N/A	DWS Full Width?	N/A
N/A	Landing Curb? (Y/N)	N/A	N/A	DWS Offset (in)	N/A
N/A	Shared Landing?	N/A			
N/A	Gutter Ponding?	N/A	N/A	Gutter Slope (%)	N/A
N/A	Gutter Lip Ht (in)	N/A	N/A	Gutter X Slope (%)	N/A
N/A	Painted X Walk1?	No	N/A	Painted X Walk2?	N/A
	X Walk 1 Direction	To NW		X Walk 2 Direction	N/A
N/A	X Walk 1 Width (in)	N/A	N/A	X Walk 2 Width (in)	N/A
	X Walk 1 Slope (%)	1.8		X Walk 2 Slope (%)	N/A
	X Walk 1 X Slope (%)	2.3		X Walk 2 X Slope (%)	N/A

N/A	Ramp inside XWalk1?	N/A	N/A	Ramp inside XWalk2?	N/A
	Road Slope (%)	N/A	N/A	Clear Space?	N/A
	Road X Slope (%)	N/A	N/A	Clear Space to XWalk (in)	N/A
N/A	Any Obstructions?	N/A	N/A	Storm Grate/Utility Hazard?	N/A
	Obstruction Type			Storm Grate/Utility Type	
		N/A			N/A
			Yes	Surface Condition? (G/P)	Good

Remove & Replace Entire Ramp.
