Access Compliance Report

Public Rights-of-Way

(Curb Ramps)

Intersection ID: 15579	Main Street: S_TRYON_ST	Cross Street: TRADE_PARK_CT	Location: N
ADA ID: BA6BCCDA778B	Ramp Type: PerpDiag	Initial Pass/Fail: Fail	Overall Compliance: No
			Severity Score: 13.75

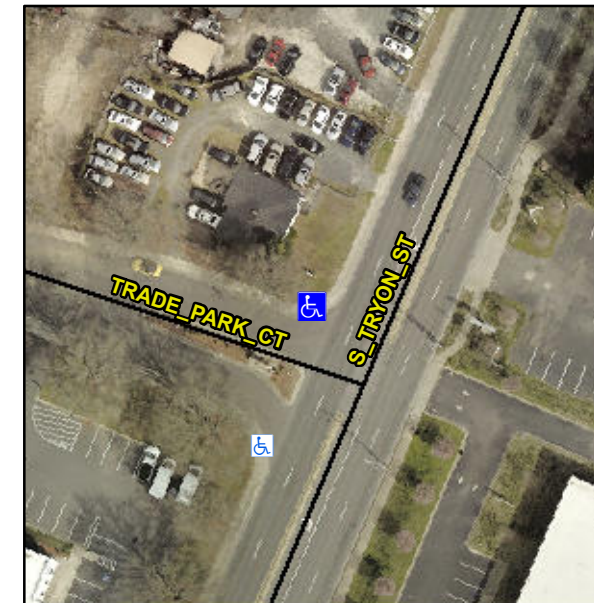
Compliance	Description	Data	Compliance	Description	Data
N/A	Ramp Length (in)	60.0	No	Ramp Slope (%)	9.2
Yes	Ramp Width (in)	48.0	No	Ramp XSlope (%)	2.6
N/A	Flare Type LT	N/A	N/A	Flare Type RT	N/A
N/A	Flare Slope LT (%)	N/A	N/A	Flare Slope RT (%)	N/A
N/A	Flare Traversable LT?	N/A	N/A	Flare Traversable RT?	N/A
N/A	Landing Length (in)	N/A	N/A	DWS Provided?	N/A
N/A	Landing Width (in)	N/A	N/A	DWS Contrast?	N/A
N/A	Landing Slope (%)	N/A	N/A	DWS Length (in)	N/A
N/A	Landing X Slope (%)	N/A	N/A	DWS Full Width?	N/A
N/A	Landing Curb? (Y/N)	N/A	N/A	DWS Offset (in)	N/A
N/A	Shared Landing?	N/A			
N/A	Gutter Ponding?	N/A	N/A	Gutter Slope (%)	N/A
N/A	Gutter Lip Ht (in)	N/A	N/A	Gutter X Slope (%)	N/A
N/A	Painted X Walk1?	No	N/A	Painted X Walk2?	No
	X Walk 1 Direction	To SW		X Walk 2 Direction	To SE
N/A	X Walk 1 Width (in)	N/A	N/A	X Walk 2 Width (in)	N/A
	X Walk 1 Slope (%)	0.3		X Walk 2 Slope (%)	3.1
	X Walk 1 X Slope (%)	3.5		X Walk 2 X Slope (%)	0.4

N/A	Ramp inside XWalk1?	N/A	N/A	Ramp inside XWalk2?	N/A
	Road Slope (%)	4.1	N/A	Clear Space?	N/A
	Road X Slope (%)	1.5	N/A	Clear Space to XWalk (in)	N/A
N/A	Any Obstructions?	N/A	N/A	Storm Grate/Utility Hazard?	N/A
	Obstruction Type			Storm Grate/Utility Type	
		N/A			N/A
			Yes	Surface Condition? (G/P)	Good

Remove & Replace Curb Ramp With Two New Directional Ramps or Equivalent.

R304.2.2, R304.5.3
