Access Compliance Report

Public Rights-of-Way

(Curb Ramps)

Intersection ID: 11129	Main Street: BECKWITH_PL	Cross Street: NEWELL_AV	Location: W
ADA ID: BA6C14A2A5A2	Ramp Type: Perp	Initial Pass/Fail: Fail	Overall Compliance: No
Severity Score: 50			
Codes/Mitigation Info/Possible Solution		Field Measurements/Component Compliance

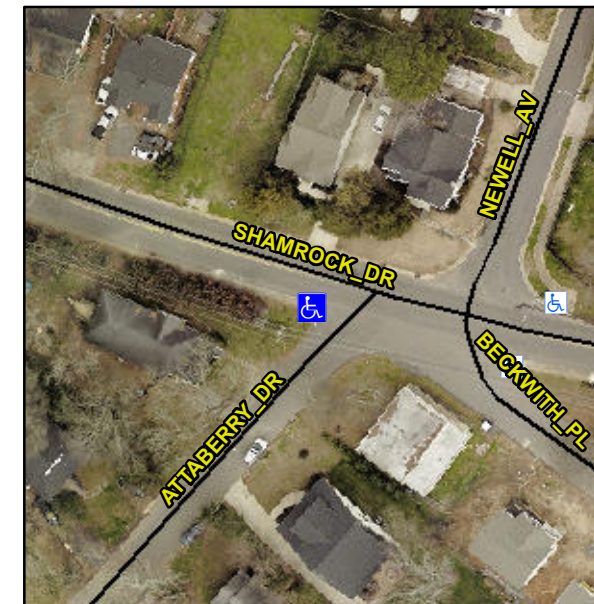
Not Found, R304.2.2, R304.5.3

Compliance	Description	Data	Compliance	Description	Data
N/A	Ramp Length (in)	51.0	No	Ramp Slope (%)	22.1
Yes	Ramp Width (in)	48.0	No	Ramp XSlope (%)	14.6
N/A	Flare Type LT	N/A	N/A	Flare Type RT	N/A
N/A	Flare Slope LT (%)	N/A	N/A	Flare Slope RT (%)	N/A
N/A	Flare Traversable LT?	N/A	N/A	Flare Traversable RT?	N/A
N/A	Landing Length (in)	N/A	N/A	DWS Provided?	N/A
N/A	Landing Width (in)	N/A	N/A	DWS Contrast?	N/A
N/A	Landing Slope (%)	N/A	N/A	DWS Length (in)	N/A
N/A	Landing X Slope (%)	N/A	N/A	DWS Full Width?	N/A
N/A	Landing Curb? (Y/N)	N/A	N/A	DWS Offset (in)	N/A
N/A	Shared Landing?	N/A			
N/A	Gutter Ponding?	N/A	N/A	Gutter Slope (%)	N/A
N/A	Gutter Lip Ht (in)	N/A	N/A	Gutter X Slope (%)	N/A
N/A	Painted X Walk1?	No	N/A	Painted X Walk2?	N/A
	X Walk 1 Direction	To SE		X Walk 2 Direction	N/A
N/A	X Walk 1 Width (in)	N/A	N/A	X Walk 2 Width (in)	N/A
	X Walk 1 Slope (%)	0.7		X Walk 2 Slope (%)	N/A
	X Walk 1 X Slope (%)	9.9		X Walk 2 X Slope (%)	N/A

N/A	Ramp inside XWalk1?	N/A	N/A	Ramp inside XWalk2?	N/A
	Road Slope (%)	N/A	N/A	Clear Space?	N/A
	Road X Slope (%)	N/A	N/A	Clear Space to XWalk (in)	N/A
N/A	Any Obstructions?	N/A	N/A	Storm Grate/Utility Hazard?	N/A
	Obstruction Type			Storm Grate/Utility Type	
		N/A			N/A
			Yes	Surface Condition? (G/P)	Good

Possible Solutions:

Remove & Replace Entire Ramp.
