# Access Compliance Report

## Public Rights-of-Way

### (Curb Ramps)

Intersection ID: 47909	Main Street: MOUNTAIN_QUAIL_DR	Cross Street: HARRIER_RD	Location: SW
ADA ID: BA75941455CE	Ramp Type: PerpDiag	Initial Pass/Fail: Fail	Overall Compliance: No
Severity Score: 33.75			
Codes/Mitigation Info/Possible Solution		Field Measurements/Component Compliance

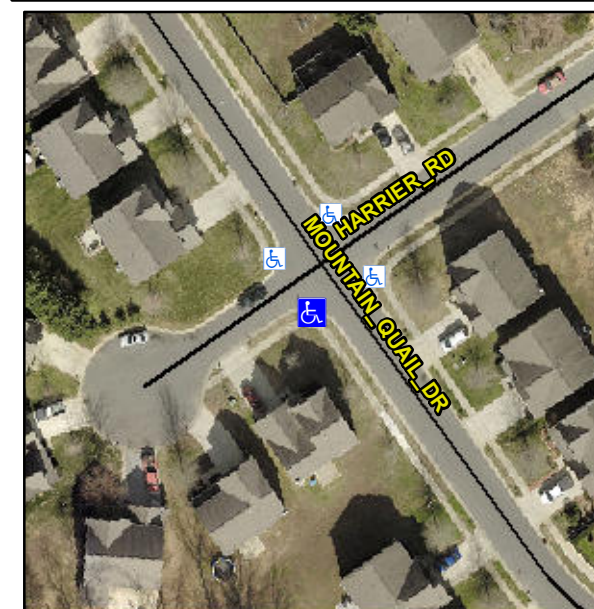
**R304.5.1, R304.5.3**

Compliance	Description	Data	Compliance	Description	Data
N/A	Ramp Length (in)	49.0	Yes	Ramp Slope (%)	7.3
No	Ramp Width (in)	39.0	No	Ramp XSlope (%)	7.0
N/A	Flare Type LT	N/A	N/A	Flare Type RT	N/A
N/A	Flare Slope LT (%)	N/A	N/A	Flare Slope RT (%)	N/A
N/A	Flare Traversable LT?	N/A	N/A	Flare Traversable RT?	N/A
N/A	Landing Length (in)	N/A	N/A	DWS Provided?	N/A
N/A	Landing Width (in)	N/A	N/A	DWS Contrast?	N/A
N/A	Landing Slope (%)	N/A	N/A	DWS Length (in)	N/A
N/A	Landing X Slope (%)	N/A	N/A	DWS Full Width?	N/A
N/A	Landing Curb? (Y/N)	N/A	N/A	DWS Offset (in)	N/A
N/A	Shared Landing?	N/A			
N/A	Gutter Ponding?	N/A	N/A	Gutter Slope (%)	N/A
N/A	Gutter Lip Ht (in)	N/A	N/A	Gutter X Slope (%)	N/A
N/A	Painted X Walk1?	No	N/A	Painted X Walk2?	No
	X Walk 1 Direction	To NE		X Walk 2 Direction	To NW
N/A	X Walk 1 Width (in)	N/A	N/A	X Walk 2 Width (in)	N/A
	X Walk 1 Slope (%)	3.9		X Walk 2 Slope (%)	0.9
	X Walk 1 X Slope (%)	2.2		X Walk 2 X Slope (%)	4.9

N/A	Ramp inside XWalk1?	N/A	N/A	Ramp inside XWalk2?	N/A
	Road Slope (%)	4.9	N/A	Clear Space?	N/A
	Road X Slope (%)	6.2	N/A	Clear Space to XWalk (in)	N/A
N/A	Any Obstructions?	N/A	N/A	Storm Grate/Utility Hazard?	N/A
	Obstruction Type			Storm Grate/Utility Type	
		N/A			N/A
			Yes	Surface Condition? (G/P)	Good

**Remove & Replace Curb Ramp With Two New Directional Ramps or Equivalent.**

Total Cost: \$ 3200.00
