# Access Compliance Report

## Public Rights-of-Way

Intersection ID: 25357	Main Street: RAINTREE_LN	Cross Street: WILLOW_POINT_DR	Location: SW
ADA ID: BA7B304190D8	Ramp Type: PerpDiag	Initial Pass/Fail: Fail	Overall Compliance: No
		Severity Score: 12.5

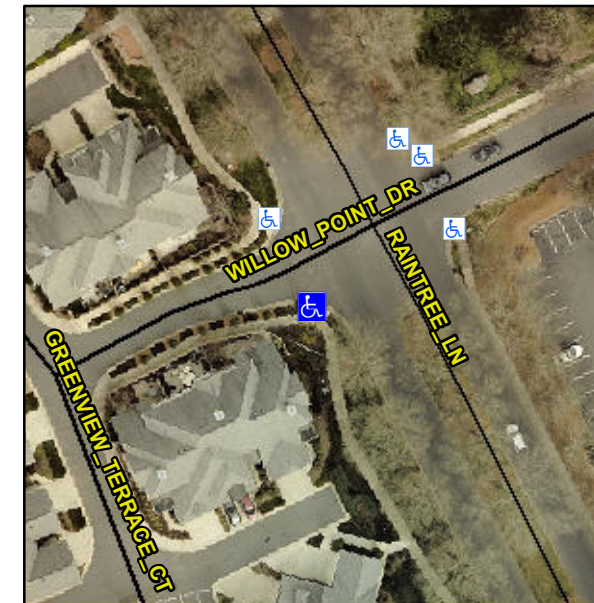
**Not Found, R304.2.2**

Compliance	Description	Data	Compliance	Description	Data
N/A	Ramp Length (in)	48.0	No	Ramp Slope (%)	8.8
Yes	Ramp Width (in)	48.0	Yes	Ramp XSlope (%)	1.7
N/A	Flare Type LT	N/A	N/A	Flare Type RT	N/A
N/A	Flare Slope LT (%)	N/A	N/A	Flare Slope RT (%)	N/A
N/A	Flare Traversable LT?	N/A	N/A	Flare Traversable RT?	N/A
N/A	Landing Length (in)	N/A	N/A	DWS Provided?	N/A
N/A	Landing Width (in)	N/A	N/A	DWS Contrast?	N/A
N/A	Landing Slope (%)	N/A	N/A	DWS Length (in)	N/A
N/A	Landing X Slope (%)	N/A	N/A	DWS Full Width?	N/A
N/A	Landing Curb? (Y/N)	N/A	N/A	DWS Offset (in)	N/A
N/A	Shared Landing?	N/A			
N/A	Gutter Ponding?	N/A	N/A	Gutter Slope (%)	N/A
N/A	Gutter Lip Ht (in)	N/A	N/A	Gutter X Slope (%)	N/A
N/A	Painted X Walk1?	No	N/A	Painted X Walk2?	No
	X Walk 1 Direction	To NE		X Walk 2 Direction	To NW
N/A	X Walk 1 Width (in)	N/A	N/A	X Walk 2 Width (in)	N/A
	X Walk 1 Slope (%)	2.4		X Walk 2 Slope (%)	0.5
	X Walk 1 X Slope (%)	1.5		X Walk 2 X Slope (%)	3.7

N/A	Ramp inside XWalk1?	N/A	N/A	Ramp inside XWalk2?	N/A
	Road Slope (%)	3.8	N/A	Clear Space?	N/A
	Road X Slope (%)	0.7	N/A	Clear Space to XWalk (in)	N/A
N/A	Any Obstructions?	N/A	N/A	Storm Grate/Utility Hazard?	N/A
	Obstruction Type			Storm Grate/Utility Type	
		N/A			N/A
			Yes	Surface Condition? (G/P)	Good

**Remove & Replace Curb Ramp With Two New Directional Ramps or Equivalent.**
