# Access Compliance Report

## Public Rights-of-Way

### (Curb Ramps)

Intersection ID: 17134	Main Street: CODDINGTON_PL	Cross Street: RANDOLPH_RD	Location: W
ADA ID: BA80A466095A	Ramp Type: PerpDiag	Initial Pass/Fail: Fail	Overall Compliance: No
Codes/Mitigation Info/Possible Solution		Field Measurements/Component Compliance	
Severity Score: 12.5

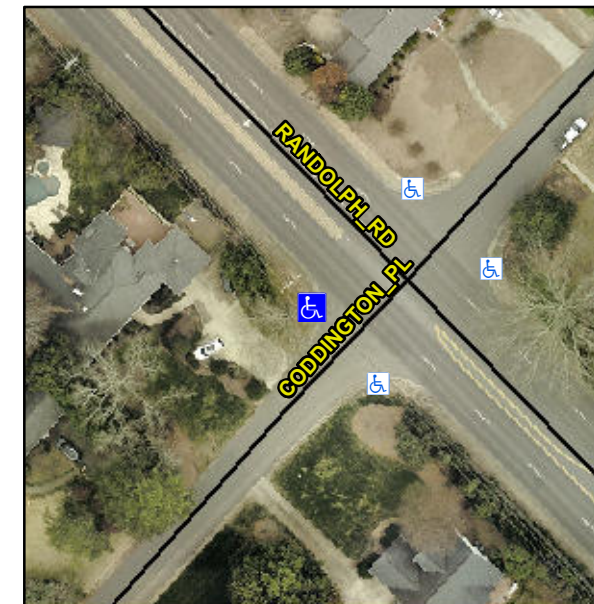
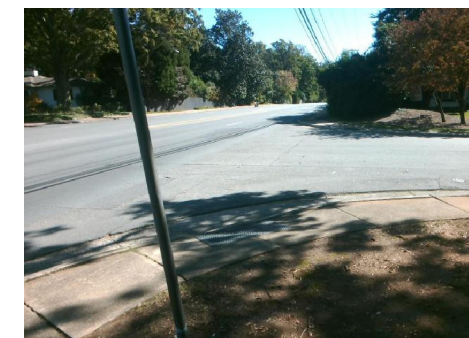
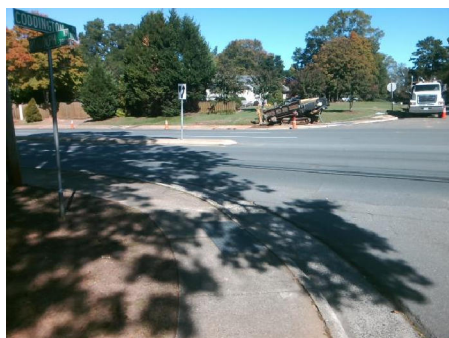
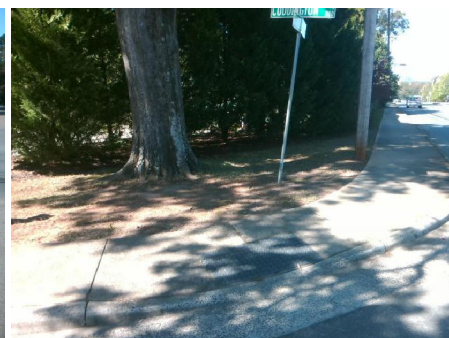
**Not Found, R304.2.2**

Compliance	Description	Data	Compliance	Description	Data
N/A	Ramp Length (in)	48.0	No	Ramp Slope (%)	10.7
Yes	Ramp Width (in)	48.0	Yes	Ramp XSlope (%)	0.6
N/A	Flare Type LT	N/A	N/A	Flare Type RT	N/A
N/A	Flare Slope LT (%)	N/A	N/A	Flare Slope RT (%)	N/A
N/A	Flare Traversable LT?	N/A	N/A	Flare Traversable RT?	N/A
N/A	Landing Length (in)	N/A	N/A	DWS Provided?	N/A
N/A	Landing Width (in)	N/A	N/A	DWS Contrast?	N/A
N/A	Landing Slope (%)	N/A	N/A	DWS Length (in)	N/A
N/A	Landing X Slope (%)	N/A	N/A	DWS Full Width?	N/A
N/A	Landing Curb? (Y/N)	N/A	N/A	DWS Offset (in)	N/A
N/A	Shared Landing?	N/A			
N/A	Gutter Ponding?	N/A	N/A	Gutter Slope (%)	N/A
N/A	Gutter Lip Ht (in)	N/A	N/A	Gutter X Slope (%)	N/A
N/A	Painted X Walk1?	No	N/A	Painted X Walk2?	No
	X Walk 1 Direction	To SE		X Walk 2 Direction	To NE
N/A	X Walk 1 Width (in)	N/A	N/A	X Walk 2 Width (in)	N/A
	X Walk 1 Slope (%)	2.4		X Walk 2 Slope (%)	2.4
	X Walk 1 X Slope (%)	0.3		X Walk 2 X Slope (%)	2.6

N/A	Ramp inside XWalk1?	N/A	N/A	Ramp inside XWalk2?	N/A
	Road Slope (%)	1.8	N/A	Clear Space?	N/A
	Road X Slope (%)	2.2	N/A	Clear Space to XWalk (in)	N/A
N/A	Any Obstructions?	N/A	N/A	Storm Grate/Utility Hazard?	N/A
	Obstruction Type			Storm Grate/Utility Type	
		N/A			N/A
			Yes	Surface Condition? (G/P)	Good

**Remove & Replace Curb Ramp With Two New Directional Ramps or Equivalent.**
