# Access Compliance Report

## Public Rights-of-Way

### (Curb Ramps)

| Intersection ID: 48949 | Main Street: OLD_STONE_CROSSING_DR | Cross Street: DAVID_JENNINGS_AV | Location: SE |

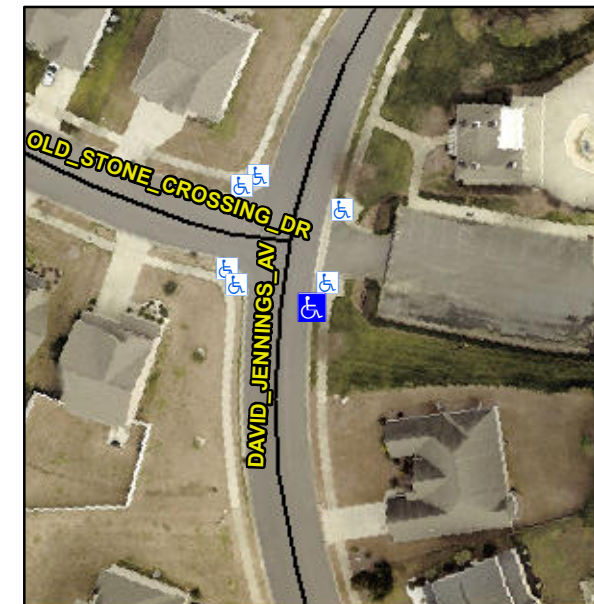
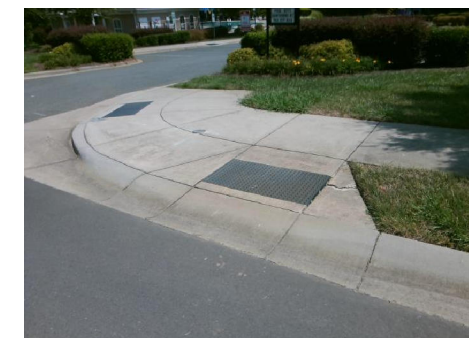
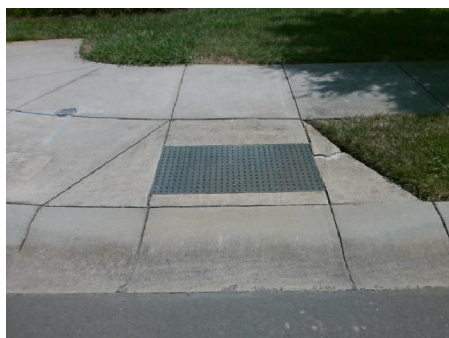
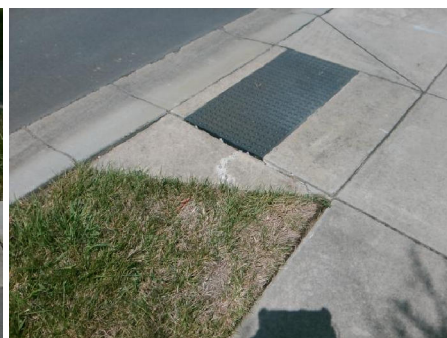
**Not Found, R304.5.3, R305.2,  
R304.5.4**

| Compliance | Description | Data | Compliance | Description | Data |
|---|---|---|---|---|---|
| Yes | Ramp Width (in) | 48.0 | No | Ramp XSlope (%) | 3.0 |
| No | Landing X Slope (%) | 2.3 | Yes | DWS Full Width? | Yes |
| N/A | Landing Curb? (Y/N) | No | No | DWS Offset (in) | 5.0 |
| Yes | Gutter Ponding? | No | No | Gutter Slope (%) | 12.5 |

**Remove & Replace Entire Ramp.  
Remove & Replace Gutter.**
