# Access Compliance Report

## Public Rights-of-Way

### (Curb Ramps)

Intersection ID: 24503	Main Street: BRUFF_CT	Cross Street: SAINTFIELD_PL	Location: SE
ADA ID: BA8C56159CAE	Ramp Type: Perp	Initial Pass/Fail: Fail	Overall Compliance: No
Severity Score: 21.25			
Codes/Mitigation Info/Possible Solution		Field Measurements/Component Compliance

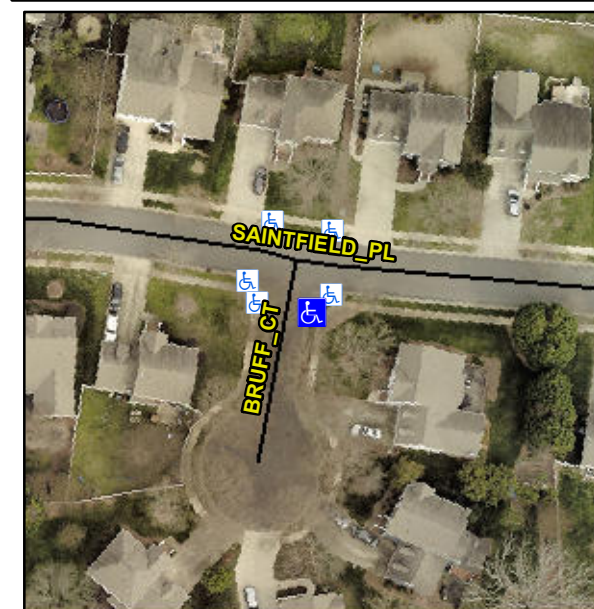
Compliance	Description	Data	Compliance	Description	Data
N/A	Ramp Length (in)	47.0	No	Ramp Slope (%)	8.8
No	Ramp Width (in)	47.0	Yes	Ramp XSlope (%)	0.9
N/A	Flare Type LT	N/A	N/A	Flare Type RT	N/A
N/A	Flare Slope LT (%)	N/A	N/A	Flare Slope RT (%)	N/A
N/A	Flare Traversable LT?	N/A	N/A	Flare Traversable RT?	N/A
N/A	Landing Length (in)	N/A	N/A	DWS Provided?	N/A
N/A	Landing Width (in)	N/A	N/A	DWS Contrast?	N/A
N/A	Landing Slope (%)	N/A	N/A	DWS Length (in)	N/A
N/A	Landing X Slope (%)	N/A	N/A	DWS Full Width?	N/A
N/A	Landing Curb? (Y/N)	N/A	N/A	DWS Offset (in)	N/A
N/A	Shared Landing?	N/A			
N/A	Gutter Ponding?	N/A	N/A	Gutter Slope (%)	N/A
N/A	Gutter Lip Ht (in)	N/A	N/A	Gutter X Slope (%)	N/A
N/A	Painted X Walk1?	No	N/A	Painted X Walk2?	N/A
	X Walk 1 Direction	To W		X Walk 2 Direction	N/A
N/A	X Walk 1 Width (in)	N/A	N/A	X Walk 2 Width (in)	N/A
	X Walk 1 Slope (%)	0.6		X Walk 2 Slope (%)	N/A
	X Walk 1 X Slope (%)	1.0		X Walk 2 X Slope (%)	N/A

N/A	Ramp inside XWalk1?	N/A	N/A	Ramp inside XWalk2?	N/A
	Road Slope (%)	N/A	N/A	Clear Space?	N/A
	Road X Slope (%)	N/A	N/A	Clear Space to XWalk (in)	N/A
N/A	Any Obstructions?	N/A	N/A	Storm Grate/Utility Hazard?	N/A
	Obstruction Type			Storm Grate/Utility Type	
		N/A			N/A
		Yes		Surface Condition? (G/P)	Good

Possible Solutions:

**Remove & Replace Entire Ramp.**
