# Access Compliance Report

## Public Rights-of-Way (Curb Ramps)

Intersection ID: 42780	Main Street: SILVERSWORD_DR	Cross Street: PURPLE_DAWN_DR	Location: SE
ADA ID: BA8DFD277CBB	Ramp Type: PerpDiag	Initial Pass/Fail: Fail	Overall Compliance: No
Severity Score: 46.25			
Codes/Mitigation Info/Possible Solution		Field Measurements/Component Compliance

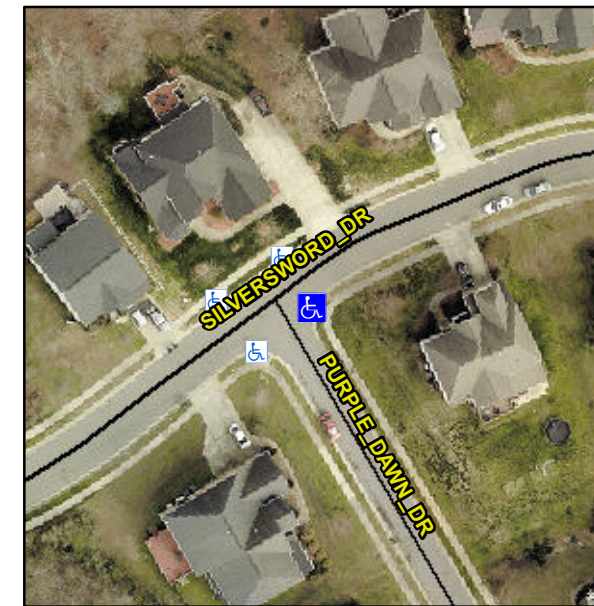
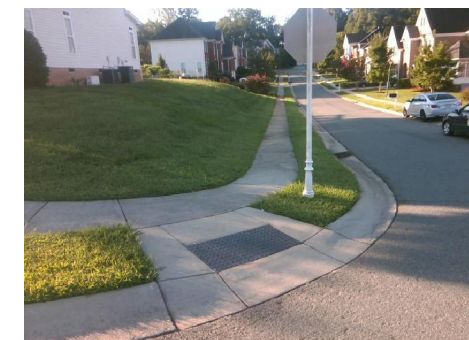
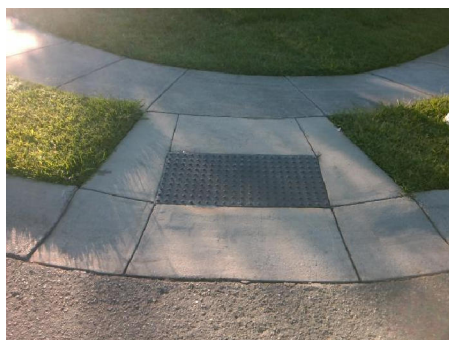
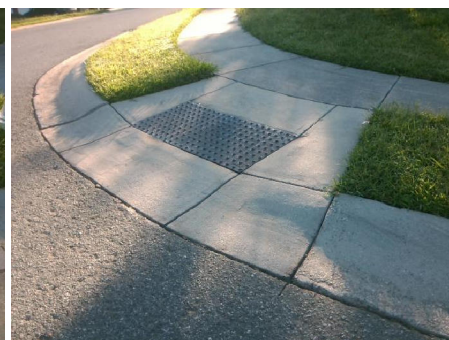
**Not Found, R304.5.1, R304.2.2, R304.5.3**

Compliance	Description	Data	Compliance	Description	Data
N/A	Ramp Length (in)	49.0	No	Ramp Slope (%)	10.2
No	Ramp Width (in)	44.5	No	Ramp XSlope (%)	9.6
N/A	Flare Type LT	N/A	N/A	Flare Type RT	N/A
N/A	Flare Slope LT (%)	N/A	N/A	Flare Slope RT (%)	N/A
N/A	Flare Traversable LT?	N/A	N/A	Flare Traversable RT?	N/A
N/A	Landing Length (in)	N/A	N/A	DWS Provided?	N/A
N/A	Landing Width (in)	N/A	N/A	DWS Contrast?	N/A
N/A	Landing Slope (%)	N/A	N/A	DWS Length (in)	N/A
N/A	Landing X Slope (%)	N/A	N/A	DWS Full Width?	N/A
N/A	Landing Curb? (Y/N)	N/A	N/A	DWS Offset (in)	N/A
N/A	Shared Landing?	N/A			
N/A	Gutter Ponding?	N/A	N/A	Gutter Slope (%)	N/A
N/A	Gutter Lip Ht (in)	N/A	N/A	Gutter X Slope (%)	N/A
N/A	Painted X Walk1?	No	N/A	Painted X Walk2?	No
	X Walk 1 Direction	To NW		X Walk 2 Direction	To SW
N/A	X Walk 1 Width (in)	N/A	N/A	X Walk 2 Width (in)	N/A
	X Walk 1 Slope (%)	2.0		X Walk 2 Slope (%)	3.1
	X Walk 1 X Slope (%)	5.5		X Walk 2 X Slope (%)	5.6

N/A	Ramp inside XWalk1?	N/A	N/A	Ramp inside XWalk2?	N/A
	Road Slope (%)	8.1	N/A	Clear Space?	N/A
	Road X Slope (%)	2.4	N/A	Clear Space to XWalk (in)	N/A
N/A	Any Obstructions?	N/A	N/A	Storm Grate/Utility Hazard?	N/A
	Obstruction Type			Storm Grate/Utility Type	
		N/A			N/A
			Yes	Surface Condition? (G/P)	Good

**Remove & Replace Curb Ramp With Two New Directional Ramps or Equivalent.**
