Access Compliance Report

Public Rights-of-Way

(Curb Ramps)

Intersection ID: 44723	Main Street: PROSPERITY_CHURCH_RD	Cross Street: JOHNSTON_OEHLER_RD	Location: SW
ADA ID: BA8EF1915D12	Ramp Type: Perp	Initial Pass/Fail: Fail	Overall Compliance: No
Codes/Mitigation Info/Possible Solution		Field Measurements/Component Compliance	
Severity Score: 21.25

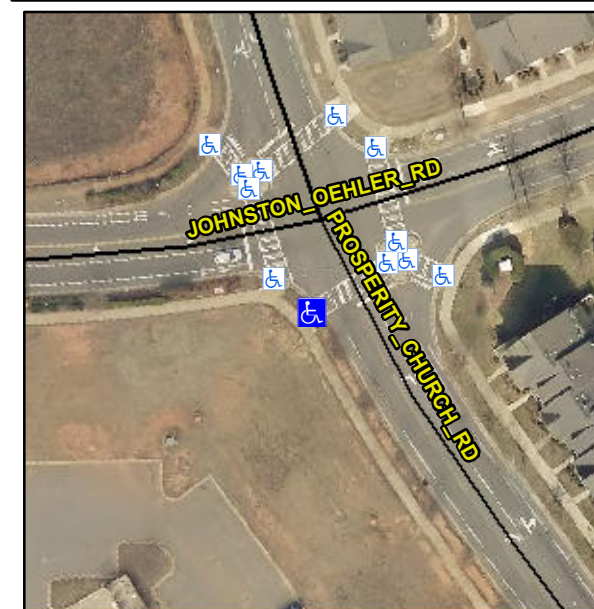
R304.5.1, R304.2.2

Compliance	Description	Data	Compliance	Description	Data
N/A	Ramp Length (in)	96.0	No	Ramp Slope (%)	9.4
No	Ramp Width (in)	46.0	Yes	Ramp XSlope (%)	0.9
N/A	Flare Type LT	N/A	N/A	Flare Type RT	N/A
N/A	Flare Slope LT (%)	N/A	N/A	Flare Slope RT (%)	N/A
N/A	Flare Traversable LT?	N/A	N/A	Flare Traversable RT?	N/A
N/A	Landing Length (in)	N/A	N/A	DWS Provided?	N/A
N/A	Landing Width (in)	N/A	N/A	DWS Contrast?	N/A
N/A	Landing Slope (%)	N/A	N/A	DWS Length (in)	N/A
N/A	Landing X Slope (%)	N/A	N/A	DWS Full Width?	N/A
N/A	Landing Curb? (Y/N)	N/A	N/A	DWS Offset (in)	N/A
N/A	Shared Landing?	N/A			
N/A	Gutter Ponding?	N/A	N/A	Gutter Slope (%)	N/A
N/A	Gutter Lip Ht (in)	N/A	N/A	Gutter X Slope (%)	N/A
N/A	Painted X Walk1?	Yes	N/A	Painted X Walk2?	N/A
	X Walk 1 Direction	To E		X Walk 2 Direction	N/A
N/A	X Walk 1 Width (in)	110.0	N/A	X Walk 2 Width (in)	N/A
	X Walk 1 Slope (%)	0.1		X Walk 2 Slope (%)	N/A
	X Walk 1 X Slope (%)	2.4		X Walk 2 X Slope (%)	N/A

N/A	Ramp inside XWalk1?	Yes	N/A	Ramp inside XWalk2?	N/A
	Road Slope (%)	N/A	N/A	Clear Space?	N/A
	Road X Slope (%)	N/A	N/A	Clear Space to XWalk (in)	N/A
N/A	Any Obstructions?	N/A	N/A	Storm Grate/Utility Hazard?	N/A
	Obstruction Type			Storm Grate/Utility Type	
		N/A			N/A
			Yes	Surface Condition? (G/P)	Good

Remove & Replace Entire Ramp.
