Access Compliance Report

Public Rights-of-Way

(Curb Ramps)

Intersection ID: 31478	Main Street: ALSTON_HILL_DR	Cross Street: ELISE_MARIE_DR	Location:	N
ADA ID: BA9E94FCEA5A	Ramp Type: PerpDiag	Initial Pass/Fail: Fail	Overall Compliance: No	Severity Score: 8.75
Codes/Mitigation Info/Possible Solution		Field Measurements/Component Compliance

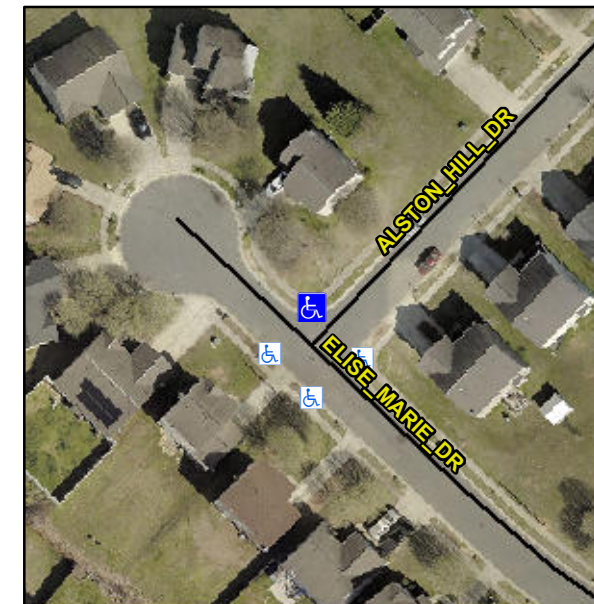
Not Found, R304.5.1

Compliance	Description	Data	Compliance	Description	Data
N/A	Ramp Length (in)	47.0	Yes	Ramp Slope (%)	7.5
No	Ramp Width (in)	47.0	Yes	Ramp XSlope (%)	0.2
N/A	Flare Type LT	N/A	N/A	Flare Type RT	N/A
N/A	Flare Slope LT (%)	N/A	N/A	Flare Slope RT (%)	N/A
N/A	Flare Traversable LT?	N/A	N/A	Flare Traversable RT?	N/A
N/A	Landing Length (in)	N/A	N/A	DWS Provided?	N/A
N/A	Landing Width (in)	N/A	N/A	DWS Contrast?	N/A
N/A	Landing Slope (%)	N/A	N/A	DWS Length (in)	N/A
N/A	Landing X Slope (%)	N/A	N/A	DWS Full Width?	N/A
N/A	Landing Curb? (Y/N)	N/A	N/A	DWS Offset (in)	N/A
N/A	Shared Landing?	N/A			
N/A	Gutter Ponding?	Yes	N/A	Gutter Slope (%)	N/A
N/A	Gutter Lip Ht (in)	N/A	N/A	Gutter X Slope (%)	N/A
N/A	Painted X Walk1?	No	N/A	Painted X Walk2?	No
	X Walk 1 Direction	To SW		X Walk 2 Direction	To SE
N/A	X Walk 1 Width (in)	N/A	N/A	X Walk 2 Width (in)	N/A
	X Walk 1 Slope (%)	2.3		X Walk 2 Slope (%)	4.8
	X Walk 1 X Slope (%)	4.7		X Walk 2 X Slope (%)	2.2

N/A	Ramp inside XWalk1?	N/A	N/A	Ramp inside XWalk2?	N/A
	Road Slope (%)	0.5	N/A	Clear Space?	N/A
	Road X Slope (%)	6.0	N/A	Clear Space to XWalk (in)	N/A
N/A	Any Obstructions?	N/A	N/A	Storm Grate/Utility Hazard?	N/A
	Obstruction Type			Storm Grate/Utility Type	
		N/A			N/A
		Yes		Surface Condition? (G/P)	Good

Remove & Replace Curb Ramp With Two New Directional Ramps or Equivalent.
