Access Compliance Report

Public Rights-of-Way

(Curb Ramps)

Intersection ID: 8146	Main Street: CINDERELLA_RD	Cross Street: FIRESIDE_DR	Location:	NW
ADA ID: BAA31F2D9AC6	Ramp Type: Perp	Initial Pass/Fail: Fail	Overall Compliance: No	Severity Score: 10
Codes/Mitigation Info/Possible Solution		Field Measurements/Component Compliance

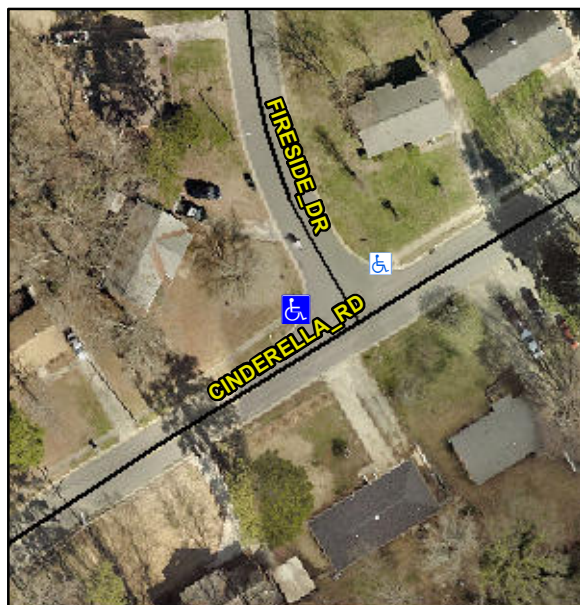
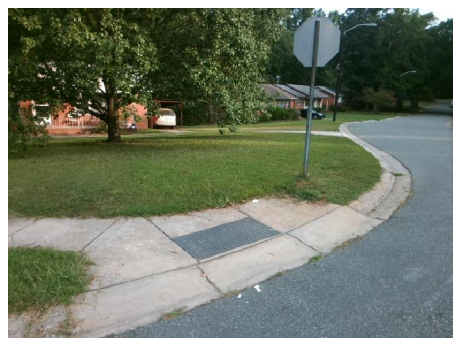
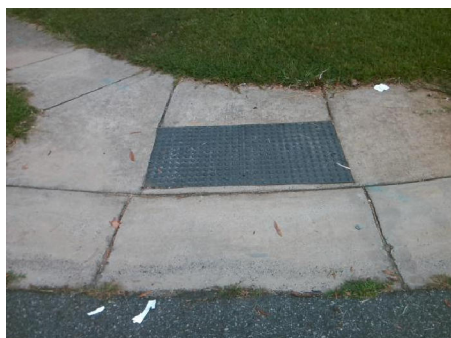
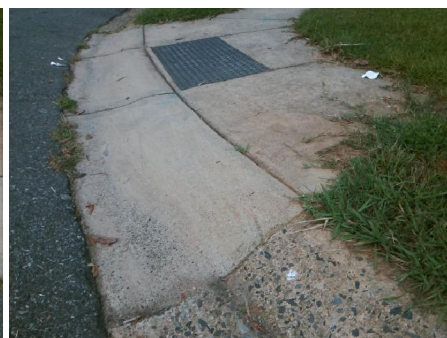
Compliance	Description	Data	Compliance	Description	Data
N/A	Ramp Length (in)	45.0	Yes	Ramp Slope (%)	5.1
No	Ramp Width (in)	47.0	No	Ramp XSlope (%)	3.3
N/A	Flare Type LT	N/A	N/A	Flare Type RT	N/A
N/A	Flare Slope LT (%)	N/A	N/A	Flare Slope RT (%)	N/A
N/A	Flare Traversable LT?	N/A	N/A	Flare Traversable RT?	N/A
N/A	Landing Length (in)	N/A	N/A	DWS Provided?	N/A
N/A	Landing Width (in)	N/A	N/A	DWS Contrast?	N/A
N/A	Landing Slope (%)	N/A	N/A	DWS Length (in)	N/A
N/A	Landing X Slope (%)	N/A	N/A	DWS Full Width?	N/A
N/A	Landing Curb? (Y/N)	N/A	N/A	DWS Offset (in)	N/A
N/A	Shared Landing?	N/A			
N/A	Gutter Ponding?	N/A	N/A	Gutter Slope (%)	N/A
N/A	Gutter Lip Ht (in)	0.5	N/A	Gutter X Slope (%)	N/A
N/A	Painted X Walk1?	No	N/A	Painted X Walk2?	N/A
	X Walk 1 Direction	To NE		X Walk 2 Direction	N/A
N/A	X Walk 1 Width (in)	N/A	N/A	X Walk 2 Width (in)	N/A
	X Walk 1 Slope (%)	7.0		X Walk 2 Slope (%)	N/A
	X Walk 1 X Slope (%)	3.7		X Walk 2 X Slope (%)	N/A

N/A	Ramp inside XWalk1?	N/A	N/A	Ramp inside XWalk2?	N/A
	Road Slope (%)	N/A	N/A	Clear Space?	N/A
	Road X Slope (%)	N/A	N/A	Clear Space to XWalk (in)	N/A
N/A	Any Obstructions?	N/A	N/A	Storm Grate/Utility Hazard?	N/A
	Obstruction Type			Storm Grate/Utility Type	
		N/A			N/A
			Yes	Surface Condition? (G/P)	Good

Remove & Replace Entire Ramp.
