# Access Compliance Report

## Public Rights-of-Way

### (Curb Ramps)

Intersection ID: 3893	Main Street: DANIELLE CHRISTINA CT	Cross Street: OVERLOOK COVE RD	Location: NW
ADA ID: BAAECA58635E	Ramp Type: Perp	Initial Pass/Fail: Fail	Overall Compliance: No
Codes/Mitigation Info/Possible Solution		Field Measurements/Component Compliance	
Severity Score: 18.75

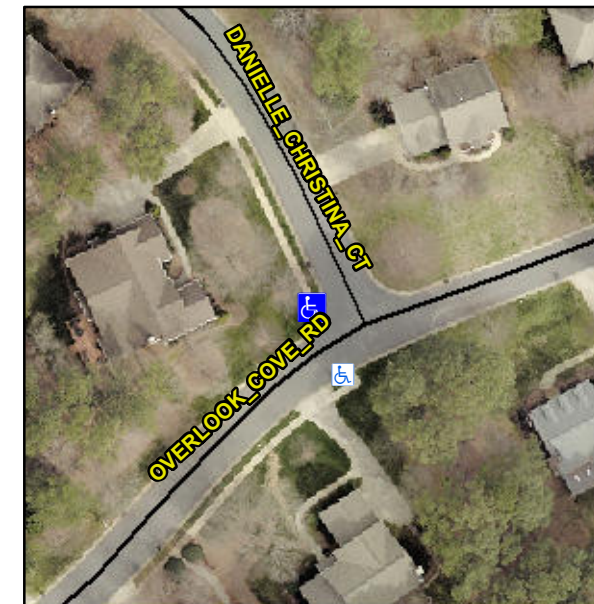
**Not Found, R304.5.1, R304.5.3**

Compliance	Description	Data	Compliance	Description	Data
N/A	Ramp Length (in)	100.0	Yes	Ramp Slope (%)	7.3
No	Ramp Width (in)	32.0	No	Ramp XSlope (%)	2.1
N/A	Flare Type LT	N/A	N/A	Flare Type RT	N/A
N/A	Flare Slope LT (%)	N/A	N/A	Flare Slope RT (%)	N/A
N/A	Flare Traversable LT?	N/A	N/A	Flare Traversable RT?	N/A
N/A	Landing Length (in)	N/A	N/A	DWS Provided?	N/A
N/A	Landing Width (in)	N/A	N/A	DWS Contrast?	N/A
N/A	Landing Slope (%)	N/A	N/A	DWS Length (in)	N/A
N/A	Landing X Slope (%)	N/A	N/A	DWS Full Width?	N/A
N/A	Landing Curb? (Y/N)	N/A	N/A	DWS Offset (in)	N/A
N/A	Shared Landing?	N/A			
N/A	Gutter Ponding?	N/A	N/A	Gutter Slope (%)	N/A
N/A	Gutter Lip Ht (in)	N/A	N/A	Gutter X Slope (%)	N/A
N/A	Painted X Walk1?	No	N/A	Painted X Walk2?	N/A
	X Walk 1 Direction	To S		X Walk 2 Direction	N/A
N/A	X Walk 1 Width (in)	N/A	N/A	X Walk 2 Width (in)	N/A
	X Walk 1 Slope (%)	0.3		X Walk 2 Slope (%)	N/A
	X Walk 1 X Slope (%)	1.7		X Walk 2 X Slope (%)	N/A

N/A	Ramp inside XWalk1?	N/A	N/A	Ramp inside XWalk2?	N/A
	Road Slope (%)	N/A	N/A	Clear Space?	N/A
	Road X Slope (%)	N/A	N/A	Clear Space to XWalk (in)	N/A
N/A	Any Obstructions?	N/A	N/A	Storm Grate/Utility Hazard?	N/A
	Obstruction Type			Storm Grate/Utility Type	
		N/A			N/A
			Yes	Surface Condition? (G/P)	Good

Possible Solutions:

**Remove & Replace Entire Ramp.**
