Access Compliance Report

Public Rights-of-Way

(Curb Ramps)

Intersection ID: 14874	Main Street: HERMITAGE_CT	Cross Street: HERMITAGE_RD	Location:	N
ADA ID: BAB48A517493	Ramp Type: PerpDiag	Initial Pass/Fail: Fail	Overall Compliance: No	Severity Score: 25
Codes/Mitigation Info/Possible Solution		Field Measurements/Component Compliance

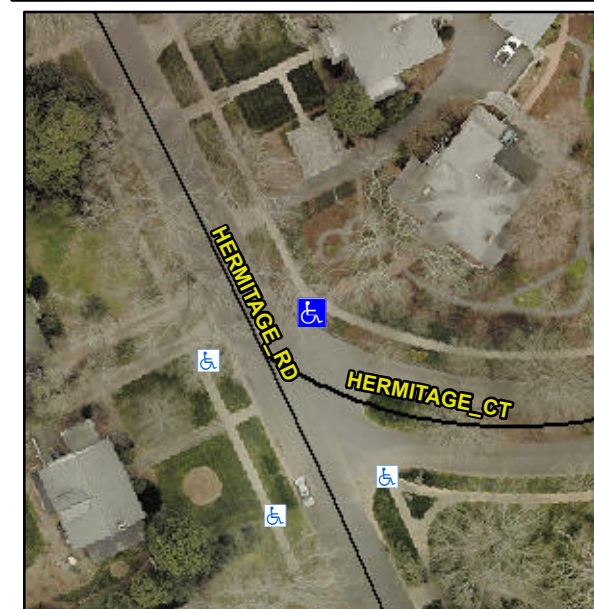
Compliance	Description	Data	Compliance	Description	Data
N/A	Ramp Length (in)	91.0	No	Ramp Slope (%)	15.2
Yes	Ramp Width (in)	48.0	Yes	Ramp XSlope (%)	1.0
N/A	Flare Type LT	N/A	N/A	Flare Type RT	N/A
N/A	Flare Slope LT (%)	N/A	N/A	Flare Slope RT (%)	N/A
N/A	Flare Traversable LT?	N/A	N/A	Flare Traversable RT?	N/A
N/A	Landing Length (in)	N/A	N/A	DWS Provided?	N/A
N/A	Landing Width (in)	N/A	N/A	DWS Contrast?	N/A
N/A	Landing Slope (%)	N/A	N/A	DWS Length (in)	N/A
N/A	Landing X Slope (%)	N/A	N/A	DWS Full Width?	N/A
N/A	Landing Curb? (Y/N)	N/A	N/A	DWS Offset (in)	N/A
N/A	Shared Landing?	N/A			
N/A	Gutter Ponding?	N/A	N/A	Gutter Slope (%)	N/A
N/A	Gutter Lip Ht (in)	N/A	N/A	Gutter X Slope (%)	N/A
N/A	Painted X Walk1?	No	N/A	Painted X Walk2?	No
	X Walk 1 Direction	To W		X Walk 2 Direction	To SE
N/A	X Walk 1 Width (in)	N/A	N/A	X Walk 2 Width (in)	N/A
	X Walk 1 Slope (%)	2.3		X Walk 2 Slope (%)	6.4
	X Walk 1 X Slope (%)	5.2		X Walk 2 X Slope (%)	2.5

N/A	Ramp inside XWalk1?	N/A	N/A	Ramp inside XWalk2?	N/A
	Road Slope (%)	4.1	N/A	Clear Space?	N/A
	Road X Slope (%)	5.5	N/A	Clear Space to XWalk (in)	N/A
N/A	Any Obstructions?	N/A	N/A	Storm Grate/Utility Hazard?	N/A
	Obstruction Type			Storm Grate/Utility Type	
		N/A			N/A
			Yes	Surface Condition? (G/P)	Good

Possible Solutions:

Remove & Replace Curb Ramp With Two New Directional Ramps or Equivalent.
