# Access Compliance Report Public Rights-of-Way (Curb Ramps)

Intersection ID: 52487      Main Street: WHITEHALL EXECUTIVE CENTER DR      Cross Street: ORLICK DR      Location: S

ADA ID: BABB8ADED4FC      Ramp Type: Perp      Initial Pass/Fail: Fail      Overall Compliance: No      Severity Score: 12.5

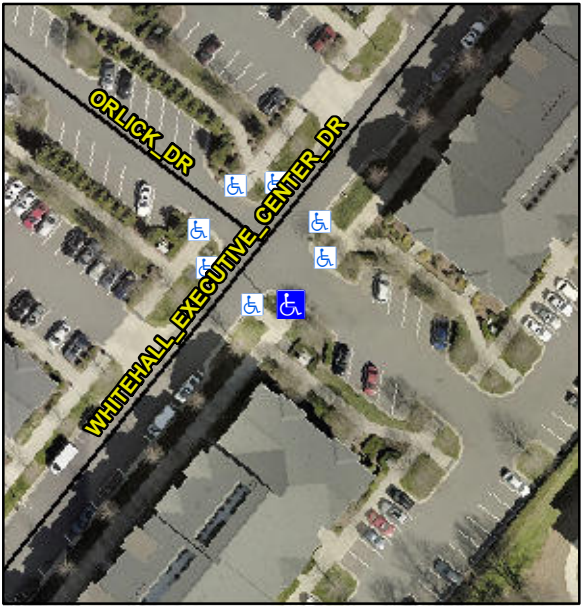
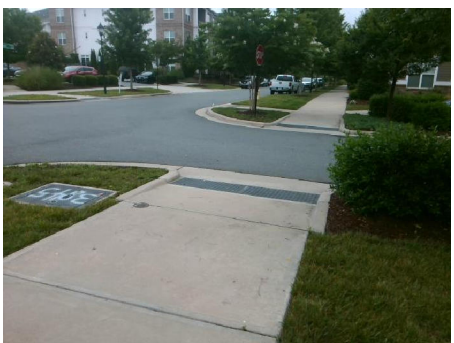
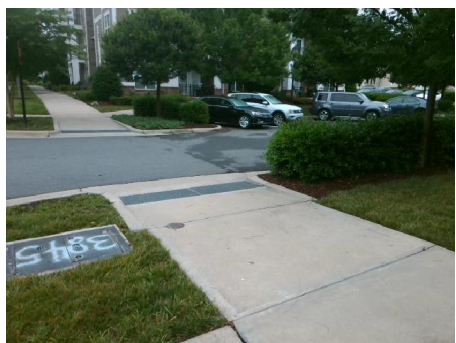
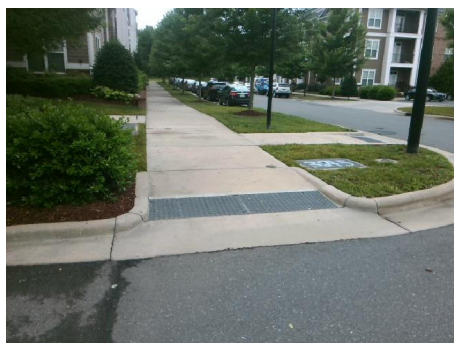
Compliance	Description	Data	Compliance	Description	Data
N/A	Ramp Length (in)	69.5	No	Ramp Slope (%)	9.6
Yes	Ramp Width (in)	94.0	Yes	Ramp XSlope (%)	1.2
N/A	Flare Type LT	N/A	N/A	Flare Type RT	N/A
N/A	Flare Slope LT (%)	N/A	N/A	Flare Slope RT (%)	N/A
N/A	Flare Traversable LT?	N/A	N/A	Flare Traversable RT?	N/A
N/A	Landing Length (in)	N/A	N/A	DWS Provided?	N/A
N/A	Landing Width (in)	N/A	N/A	DWS Contrast?	N/A
N/A	Landing Slope (%)	N/A	N/A	DWS Length (in)	N/A
N/A	Landing X Slope (%)	N/A	N/A	DWS Full Width?	N/A
N/A	Landing Curb? (Y/N)	N/A	N/A	DWS Offset (in)	N/A
N/A	Shared Landing?	N/A			
N/A	Gutter Ponding?	N/A	N/A	Gutter Slope (%)	N/A
N/A	Gutter Lip Ht (in)	N/A	N/A	Gutter X Slope (%)	N/A
N/A	Painted X Walk1?	No	N/A	Painted X Walk2?	N/A
	X Walk 1 Direction	To NE		X Walk 2 Direction	N/A
N/A	X Walk 1 Width (in)	N/A	N/A	X Walk 2 Width (in)	N/A
	X Walk 1 Slope (%)	1.1		X Walk 2 Slope (%)	N/A
	X Walk 1 X Slope (%)	1.4		X Walk 2 X Slope (%)	N/A

N/A	Ramp inside XWalk1?	N/A	N/A	Ramp inside XWalk2?	N/A
	Road Slope (%)	N/A	N/A	Clear Space?	N/A
	Road X Slope (%)	N/A	N/A	Clear Space to XWalk (in)	N/A
N/A	Any Obstructions?	N/A	N/A	Storm Grate/Utility Hazard?	N/A
	Obstruction Type			Storm Grate/Utility Type	
		N/A			N/A
Yes	Surface Condition? (G/P)		Yes		Good

Possible Solutions:  
**Remove & Replace Entire Ramp.**

Total Cost:      \$      **1850.00**
