Access Compliance Report

Public Rights-of-Way

(Curb Ramps)

Intersection ID: 11628	Main Street: W_8TH_ST	Cross Street: N_PINE_ST	Location: W
ADA ID: BABCAC713B2F	Ramp Type: Perp	Initial Pass/Fail: Fail	Overall Compliance: No
		Severity Score: 12.5

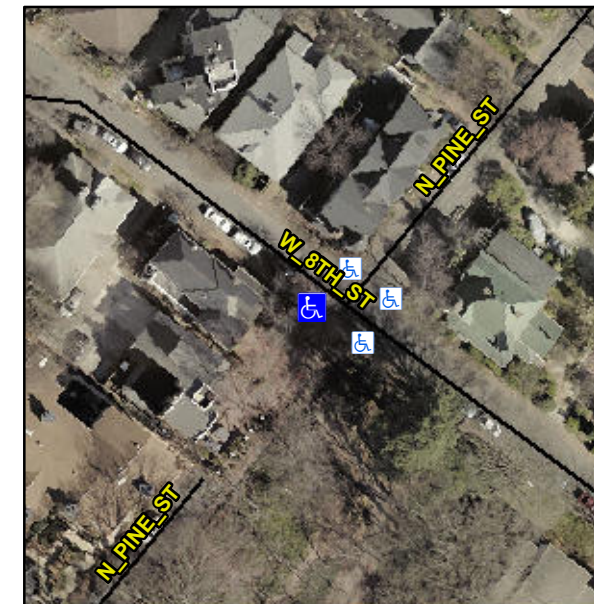
Not Found, R304.5.3

Compliance	Description	Data	Compliance	Description	Data
N/A	Ramp Length (in)	56.0	Yes	Ramp Slope (%)	7.5
Yes	Ramp Width (in)	48.0	No	Ramp XSlope (%)	5.6
N/A	Flare Type LT	N/A	N/A	Flare Type RT	N/A
N/A	Flare Slope LT (%)	N/A	N/A	Flare Slope RT (%)	N/A
N/A	Flare Traversable LT?	N/A	N/A	Flare Traversable RT?	N/A
N/A	Landing Length (in)	N/A	N/A	DWS Provided?	N/A
N/A	Landing Width (in)	N/A	N/A	DWS Contrast?	N/A
N/A	Landing Slope (%)	N/A	N/A	DWS Length (in)	N/A
N/A	Landing X Slope (%)	N/A	N/A	DWS Full Width?	N/A
N/A	Landing Curb? (Y/N)	N/A	N/A	DWS Offset (in)	N/A
N/A	Shared Landing?	N/A			
N/A	Gutter Ponding?	N/A	N/A	Gutter Slope (%)	N/A
N/A	Gutter Lip Ht (in)	N/A	N/A	Gutter X Slope (%)	N/A
N/A	Painted X Walk1?	No	N/A	Painted X Walk2?	N/A
	X Walk 1 Direction	To NE		X Walk 2 Direction	N/A
N/A	X Walk 1 Width (in)	N/A	N/A	X Walk 2 Width (in)	N/A
	X Walk 1 Slope (%)	5.0		X Walk 2 Slope (%)	N/A
	X Walk 1 X Slope (%)	3.8		X Walk 2 X Slope (%)	N/A

N/A	Ramp inside XWalk1?	N/A	N/A	Ramp inside XWalk2?	N/A
	Road Slope (%)	N/A	N/A	Clear Space?	N/A
	Road X Slope (%)	N/A	N/A	Clear Space to XWalk (in)	N/A
N/A	Any Obstructions?	N/A	N/A	Storm Grate/Utility Hazard?	N/A
	Obstruction Type			Storm Grate/Utility Type	
		N/A			N/A
			Yes	Surface Condition? (G/P)	Good

Remove & Replace Entire Ramp.

Total Cost: \$ 1850.00
