Access Compliance Report

Public Rights-of-Way

(Curb Ramps)

Intersection ID: 16487	Main Street: SPLIT_OAK_DR	Cross Street: WALNUT_CREEK_LN	Location: NE
ADA ID: BABD13AC7529	Ramp Type: PerpDiag	Initial Pass/Fail: Fail	Overall Compliance: No
		Severity Score: 12.5

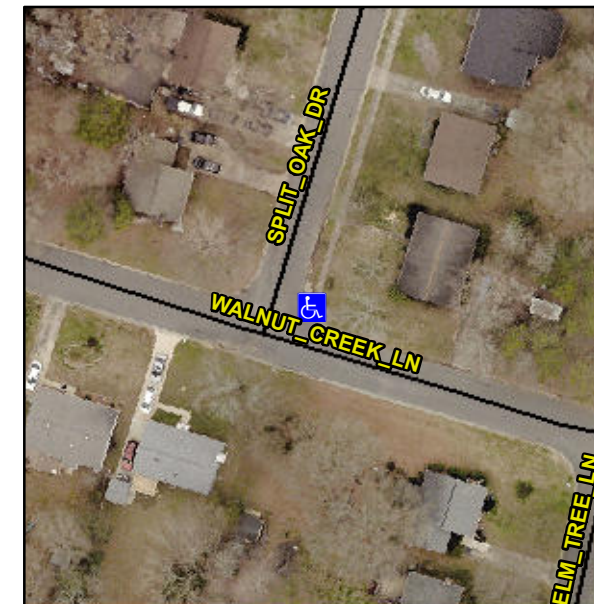
Not Found, R304.5.3

Compliance	Description	Data	Compliance	Description	Data
N/A	Ramp Length (in)	84.0	Yes	Ramp Slope (%)	7.3
Yes	Ramp Width (in)	48.0	No	Ramp XSlope (%)	5.4
N/A	Flare Type LT	N/A	N/A	Flare Type RT	N/A
N/A	Flare Slope LT (%)	N/A	N/A	Flare Slope RT (%)	N/A
N/A	Flare Traversable LT?	N/A	N/A	Flare Traversable RT?	N/A
N/A	Landing Length (in)	N/A	N/A	DWS Provided?	N/A
N/A	Landing Width (in)	N/A	N/A	DWS Contrast?	N/A
N/A	Landing Slope (%)	N/A	N/A	DWS Length (in)	N/A
N/A	Landing X Slope (%)	N/A	N/A	DWS Full Width?	N/A
N/A	Landing Curb? (Y/N)	N/A	N/A	DWS Offset (in)	N/A
N/A	Shared Landing?	N/A			
N/A	Gutter Ponding?	N/A	N/A	Gutter Slope (%)	N/A
N/A	Gutter Lip Ht (in)	N/A	N/A	Gutter X Slope (%)	N/A
N/A	Painted X Walk1?	No	N/A	Painted X Walk2?	No
	X Walk 1 Direction	To NW		X Walk 2 Direction	To SW
N/A	X Walk 1 Width (in)	N/A	N/A	X Walk 2 Width (in)	N/A
	X Walk 1 Slope (%)	7.2		X Walk 2 Slope (%)	2.9
	X Walk 1 X Slope (%)	3.2		X Walk 2 X Slope (%)	1.9

N/A	Ramp inside XWalk1?	N/A	N/A	Ramp inside XWalk2?	N/A
	Road Slope (%)	1.7	N/A	Clear Space?	N/A
	Road X Slope (%)	2.4	N/A	Clear Space to XWalk (in)	N/A
N/A	Any Obstructions?	N/A	N/A	Storm Grate/Utility Hazard?	N/A
	Obstruction Type			Storm Grate/Utility Type	
		N/A			N/A
		Yes		Surface Condition? (G/P)	Good

Remove & Replace Curb Ramp With Two New Directional Ramps or Equivalent.
