# Access Compliance Report

## Public Rights-of-Way

### (Curb Ramps)

Intersection ID: 22038	Main Street: DELPOND_LN	Cross Street: MIRABELL_RD	Location: S
ADA ID: BABD1B770E21	Ramp Type: Perp	Initial Pass/Fail: Fail	Overall Compliance: No
Codes/Mitigation Info/Possible Solution		Field Measurements/Component Compliance

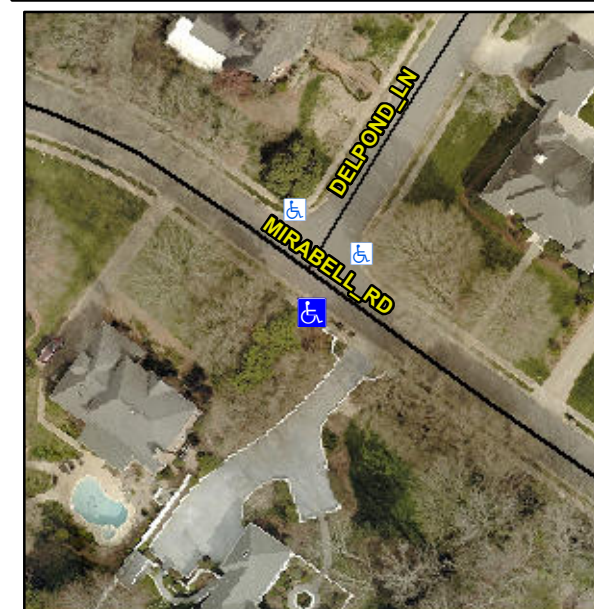
**Not Found, R304.5.1, R304.5.3**

Compliance	Description	Data	Compliance	Description	Data
N/A	Ramp Length (in)	82.0	Yes	Ramp Slope (%)	6.1
No	Ramp Width (in)	47.0	No	Ramp XSlope (%)	5.3
N/A	Flare Type LT	N/A	N/A	Flare Type RT	N/A
N/A	Flare Slope LT (%)	N/A	N/A	Flare Slope RT (%)	N/A
N/A	Flare Traversable LT?	N/A	N/A	Flare Traversable RT?	N/A
N/A	Landing Length (in)	N/A	N/A	DWS Provided?	N/A
N/A	Landing Width (in)	N/A	N/A	DWS Contrast?	N/A
N/A	Landing Slope (%)	N/A	N/A	DWS Length (in)	N/A
N/A	Landing X Slope (%)	N/A	N/A	DWS Full Width?	N/A
N/A	Landing Curb? (Y/N)	N/A	N/A	DWS Offset (in)	N/A
N/A	Shared Landing?	N/A			
N/A	Gutter Ponding?	N/A	N/A	Gutter Slope (%)	N/A
N/A	Gutter Lip Ht (in)	N/A	N/A	Gutter X Slope (%)	N/A
N/A	Painted X Walk1?	No	N/A	Painted X Walk2?	N/A
	X Walk 1 Direction	To NE		X Walk 2 Direction	N/A
N/A	X Walk 1 Width (in)	N/A	N/A	X Walk 2 Width (in)	N/A
	X Walk 1 Slope (%)	6.0		X Walk 2 Slope (%)	N/A
	X Walk 1 X Slope (%)	3.6		X Walk 2 X Slope (%)	N/A

N/A	Ramp inside XWalk1?	N/A	N/A	Ramp inside XWalk2?	N/A
	Road Slope (%)	N/A	N/A	Clear Space?	N/A
	Road X Slope (%)	N/A	N/A	Clear Space to XWalk (in)	N/A
N/A	Any Obstructions?	N/A	N/A	Storm Grate/Utility Hazard?	N/A
	Obstruction Type			Storm Grate/Utility Type	
		N/A			N/A
			Yes	Surface Condition? (G/P)	Good

**Remove & Replace Entire Ramp.**
