Access Compliance Report

Public Rights-of-Way

(Curb Ramps)

Intersection ID: 12426	Main Street: KENWOOD_AV	Cross Street: MIDWOOD_PL	Location: SE
ADA ID: BAC639C63A68	Ramp Type: Perp	Initial Pass/Fail: Fail	Overall Compliance: No
Severity Score: 10			
Codes/Mitigation Info/Possible Solution		Field Measurements/Component Compliance

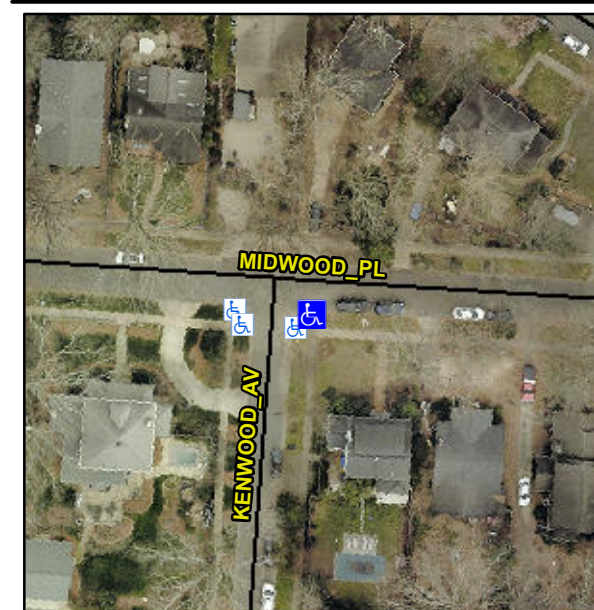
Compliance	Description	Data	Compliance	Description	Data
N/A	Ramp Length (in)	86.0	Yes	Ramp Slope (%)	7.3
No	Ramp Width (in)	43.0	Yes	Ramp XSlope (%)	3.8
N/A	Flare Type LT	N/A	N/A	Flare Type RT	N/A
N/A	Flare Slope LT (%)	N/A	N/A	Flare Slope RT (%)	N/A
N/A	Flare Traversable LT?	N/A	N/A	Flare Traversable RT?	N/A
N/A	Landing Length (in)	N/A	N/A	DWS Provided?	N/A
N/A	Landing Width (in)	N/A	N/A	DWS Contrast?	N/A
N/A	Landing Slope (%)	N/A	N/A	DWS Length (in)	N/A
N/A	Landing X Slope (%)	N/A	N/A	DWS Full Width?	N/A
N/A	Landing Curb? (Y/N)	N/A	N/A	DWS Offset (in)	N/A
N/A	Shared Landing?	N/A			
N/A	Gutter Ponding?	N/A	N/A	Gutter Slope (%)	N/A
N/A	Gutter Lip Ht (in)	N/A	N/A	Gutter X Slope (%)	N/A
N/A	Painted X Walk1?	No	N/A	Painted X Walk2?	N/A
	X Walk 1 Direction	To N		X Walk 2 Direction	N/A
N/A	X Walk 1 Width (in)	N/A	N/A	X Walk 2 Width (in)	N/A
	X Walk 1 Slope (%)	3.3		X Walk 2 Slope (%)	N/A
	X Walk 1 X Slope (%)	4.3		X Walk 2 X Slope (%)	N/A

N/A	Ramp inside XWalk1?	N/A	N/A	Ramp inside XWalk2?	N/A
	Road Slope (%)	N/A	N/A	Clear Space?	N/A
	Road X Slope (%)	N/A	N/A	Clear Space to XWalk (in)	N/A
N/A	Any Obstructions?	N/A	N/A	Storm Grate/Utility Hazard?	N/A
	Obstruction Type			Storm Grate/Utility Type	
		N/A			N/A
			Yes	Surface Condition? (G/P)	Good

Possible Solutions:

Remove & Replace Entire Ramp.
