Access Compliance Report

Public Rights-of-Way

(Curb Ramps)

Intersection ID: 12413	Main Street: N_BREVARD_ST	Cross Street: E_6TH_ST	Location: N
ADA ID: BAC95932037E	Ramp Type: Perp	Initial Pass/Fail: Fail	Overall Compliance: No
			Severity Score: 13.75

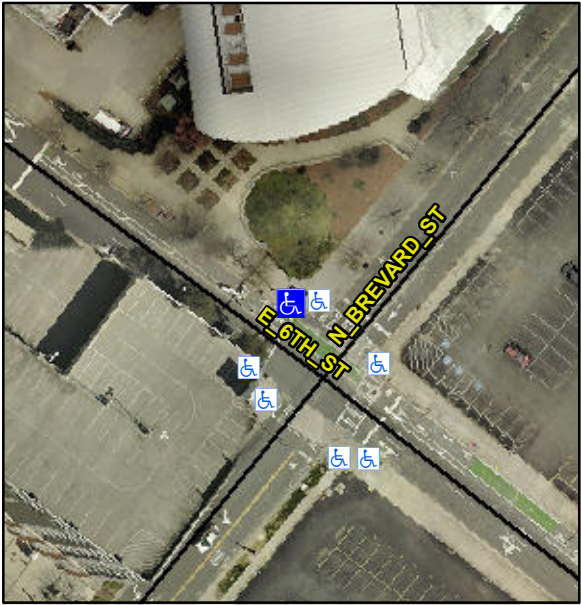
Possible Solutions:		Compliance	Description	Data
	Remove & Replace Entire Ramp.		N/A	Ramp Length (in)	71.0
			Yes	Ramp Width (in)	48.0
			N/A	Flare Type LT	N/A
			N/A	Flare Slope LT (%)	N/A
			N/A	Flare Traversable LT?	N/A
			N/A	Landing Length (in)	N/A
			N/A	Landing Width (in)	N/A
			N/A	Landing Slope (%)	N/A
			N/A	Landing X Slope (%)	N/A
<p>Surveyor Notes:</p> <p>N/A</p> <p>PROW/ADA:</p> <p>Not Found, R304.2.2, R304.5.3</p>			N/A	Flare Type RT	N/A
			N/A	Flare Slope RT (%)	N/A
			N/A	Flare Traversable RT?	N/A
			N/A	DWS Provided?	N/A
			N/A	DWS Contrast?	N/A
			N/A	DWS Length (in)	N/A
			N/A	DWS Full Width?	N/A
			N/A	DWS Offset (in)	N/A
			N/A	Shared Landing?	N/A
			N/A	Gutter Ponding?	N/A
			N/A	Gutter Lip Ht (in)	N/A
			N/A	Painted X Walk1?	Yes
				X Walk 1 Direction	To SW
			N/A	X Walk 1 Width (in)	109.0
				X Walk 1 Slope (%)	0.8

X Walk 1 X Slope (%)	1.1
			N/A	Ramp inside XWalk1?	Yes
			N/A	Road Slope (%)	N/A
			N/A	Road X Slope (%)	N/A
			N/A	Any Obstructions?	N/A
				Obstruction Type	
Total Cost:		\$ 1850.00			
			N/A		N/A
			Yes	Surface Condition? (G/P)	Good
