Access Compliance Report

Public Rights-of-Way

(Curb Ramps)

Intersection ID: 23292	Main Street: SHARON_RD_WEST	Cross Street: RIVERBIRCH_DR	Location: NW
ADA ID: BAC9CD1DEBAD	Ramp Type: PerpDiag	Initial Pass/Fail: Fail	Overall Compliance: No
			Severity Score: 13.75

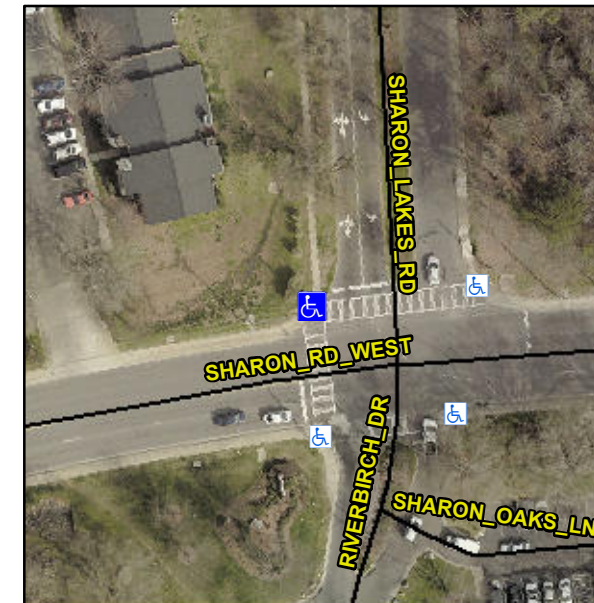
Not Found, R304.2.2, R304.5.3

Compliance	Description	Data	Compliance	Description	Data
N/A	Ramp Length (in)	58.0	No	Ramp Slope (%)	8.8
Yes	Ramp Width (in)	48.0	No	Ramp XSlope (%)	2.6
N/A	Flare Type LT	N/A	N/A	Flare Type RT	N/A
N/A	Flare Slope LT (%)	N/A	N/A	Flare Slope RT (%)	N/A
N/A	Flare Traversable LT?	N/A	N/A	Flare Traversable RT?	N/A
N/A	Landing Length (in)	N/A	N/A	DWS Provided?	N/A
N/A	Landing Width (in)	N/A	N/A	DWS Contrast?	N/A
N/A	Landing Slope (%)	N/A	N/A	DWS Length (in)	N/A
N/A	Landing X Slope (%)	N/A	N/A	DWS Full Width?	N/A
N/A	Landing Curb? (Y/N)	N/A	N/A	DWS Offset (in)	N/A
N/A	Shared Landing?	N/A			
N/A	Gutter Ponding?	N/A	N/A	Gutter Slope (%)	N/A
N/A	Gutter Lip Ht (in)	N/A	N/A	Gutter X Slope (%)	N/A
N/A	Painted X Walk1?	Yes	N/A	Painted X Walk2?	Yes
	X Walk 1 Direction	To S		X Walk 2 Direction	To E
N/A	X Walk 1 Width (in)	117.0	N/A	X Walk 2 Width (in)	113.0
	X Walk 1 Slope (%)	0.8		X Walk 2 Slope (%)	1.3
	X Walk 1 X Slope (%)	0.7		X Walk 2 X Slope (%)	0.8

N/A	Ramp inside XWalk1?	Yes	N/A	Ramp inside XWalk2?	Yes
	Road Slope (%)	0.3	N/A	Clear Space?	N/A
	Road X Slope (%)	0.1	N/A	Clear Space to XWalk (in)	N/A
N/A	Any Obstructions?	N/A	N/A	Storm Grate/Utility Hazard?	N/A
	Obstruction Type			Storm Grate/Utility Type	
		N/A			N/A
		Yes		Surface Condition? (G/P)	Good

Remove & Replace Curb Ramp With Two New Directional Ramps or Equivalent.
