Access Compliance Report Public Rights-of-Way (Curb Ramps)

Intersection ID: 13094 Main Street: WINNIFRED ST **Cross Street: WILCOX ST** Location: S

Initial Pass/Fail: Fail **Overall Compliance: No Severity Score: ADA ID: BACE4B72AA4D** Ramp Type: PerpDiag 37.5

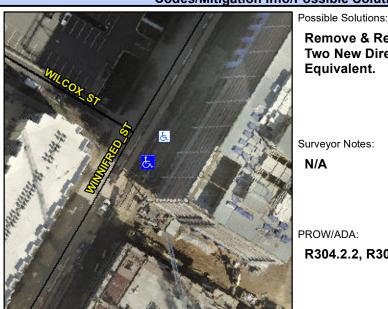
No N/A Ramp Length (in) 58.0 Ramp Slope (%) No Ramp XSlope (%) Yes Ramp Width (in) 48.0 N/A N/A Flare Type LT N/A Flare Type RT N/A N/A N/A Flare Slope RT (%) Flare Slope LT (%) N/A Flare Traversable LT? N/A N/A Flare Traversable RT? N/A N/A N/A **DWS Provided?** Landing Length (in) N/A Landing Width (in) N/A N/A **DWS Contrast?** N/A N/A N/A Landing Slope (%) DWS Length (in) N/A Landing X Slope (%) N/A N/A DWS Full Width? N/A Landing Curb? (Y/N) N/A N/A DWS Offset (in) N/A N/A Shared Landing? N/A **Gutter Ponding?** N/A N/A Gutter Slope (%) N/A Gutter Lip Ht (in) N/A N/A Gutter X Slope (%) N/A Painted X Walk1? No N/A Painted X Walk2? X Walk 1 Direction To NE X Walk 2 Direction N/A N/A X Walk 1 Width (in) X Walk 2 Width (in) X Walk 1 Slope (%) 0.5 X Walk 2 Slope (%) X Walk 1 X Slope (%) 2.5 X Walk 2 X Slope (%) N/A N/A N/A Ramp inside XWalk2? Ramp inside XWalk1? Road Slope (%) 8.0 N/A Clear Space? N/A Road X Slope (%) Clear Space to XWalk (in) 1.3 N/A N/A Any Obstructions? N/A Storm Grate/Utility Hazard? **Obstruction Type** Storm Grate/Utility Type

Remove & Replace Curb Ramp With Two New Directional Ramps or Equivalent.

R304.2.2, R304.5.3
