# Access Compliance Report

## Public Rights-of-Way

### (Curb Ramps)

Intersection ID: 45694	Main Street: E_ARROWOOD_RD	Cross Street: SILVER_ARROW_DR	Location: SE
ADA ID: BAD13308C20A	Ramp Type: PerpDiag	Initial Pass/Fail: Fail	Overall Compliance: No
Severity Score: 21.25			
Codes/Mitigation Info/Possible Solution		Field Measurements/Component Compliance

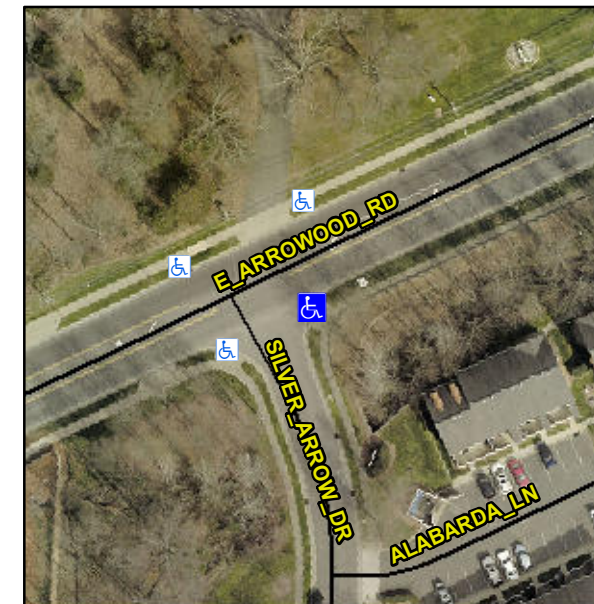
Compliance	Description	Data	Compliance	Description	Data
N/A	Ramp Length (in)	88.0	No	Ramp Slope (%)	9.8
No	Ramp Width (in)	40.5	Yes	Ramp XSlope (%)	1.8
N/A	Flare Type LT	N/A	N/A	Flare Type RT	N/A
N/A	Flare Slope LT (%)	N/A	N/A	Flare Slope RT (%)	N/A
N/A	Flare Traversable LT?	N/A	N/A	Flare Traversable RT?	N/A
N/A	Landing Length (in)	N/A	N/A	DWS Provided?	N/A
N/A	Landing Width (in)	N/A	N/A	DWS Contrast?	N/A
N/A	Landing Slope (%)	N/A	N/A	DWS Length (in)	N/A
N/A	Landing X Slope (%)	N/A	N/A	DWS Full Width?	N/A
N/A	Landing Curb? (Y/N)	N/A	N/A	DWS Offset (in)	N/A
N/A	Shared Landing?	N/A			
N/A	Gutter Ponding?	N/A	N/A	Gutter Slope (%)	N/A
N/A	Gutter Lip Ht (in)	N/A	N/A	Gutter X Slope (%)	N/A
N/A	Painted X Walk1?	No	N/A	Painted X Walk2?	No
	X Walk 1 Direction	To N		X Walk 2 Direction	To SW
N/A	X Walk 1 Width (in)	N/A	N/A	X Walk 2 Width (in)	N/A
	X Walk 1 Slope (%)	3.5		X Walk 2 Slope (%)	7.2
	X Walk 1 X Slope (%)	4.3		X Walk 2 X Slope (%)	6.5

N/A	Ramp inside XWalk1?	N/A	N/A	Ramp inside XWalk2?	N/A
	Road Slope (%)	0.4	N/A	Clear Space?	N/A
	Road X Slope (%)	7.0	N/A	Clear Space to XWalk (in)	N/A
N/A	Any Obstructions?	N/A	N/A	Storm Grate/Utility Hazard?	N/A
	Obstruction Type			Storm Grate/Utility Type	
		N/A			N/A
			Yes	Surface Condition? (G/P)	Good

**Remove & Replace Curb Ramp With Two New Directional Ramps or Equivalent.**
