Access Compliance Report

Public Rights-of-Way (Curb Ramps)

Intersection ID: 9721	Main Street: ALLENSTOWN_DR	Cross Street: BRIDGEPORT_DR	Location: NE
ADA ID: BADBEEB76820	Ramp Type: Directional	Initial Pass/Fail: Fail	Overall Compliance: No
Severity Score: 1.25			
Codes/Mitigation Info/Possible Solution		Field Measurements/Component Compliance

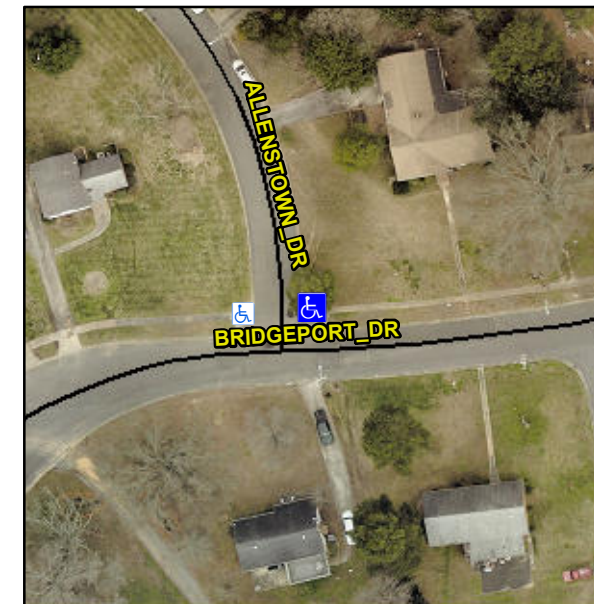
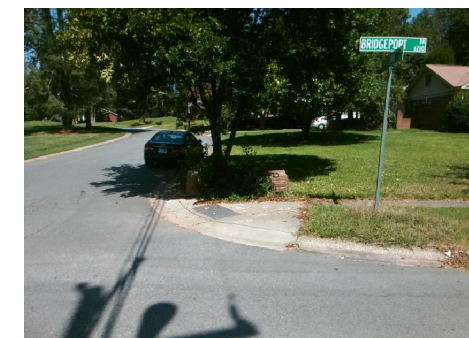
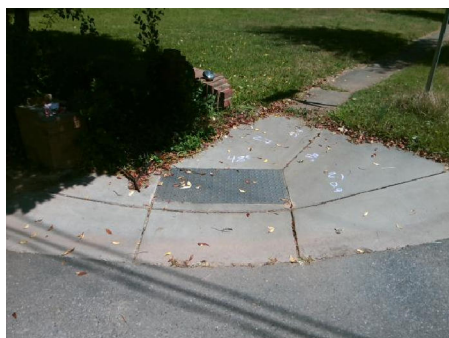
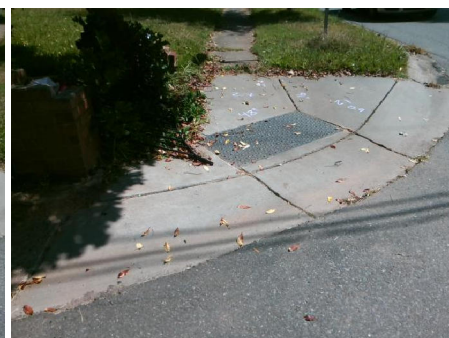
Compliance	Description	Data	Compliance	Description	Data
N/A	Ramp Length (in)	91.0	N/A	Grade Break?	N/A
Yes	Ramp Width (in)	48.0	N/A	Grade Break Slope (%)	0.0
Yes	Ramp Slope (%)	5.7	N/A	Grade Break XSlope (%)	0.0
No	Ramp XSlope (%)	2.7			
N/A	Flare Type LT	N/A	N/A	Flare Type RT	N/A
N/A	Flare Slope LT (%)	N/A	N/A	Flare Slope RT (%)	0.0
N/A	Flare Traversable LT?	N/A	N/A	Flare Traversable RT?	N/A
N/A	Landing Length (in)	0.0	N/A	DWS Provided?	N/A
N/A	Landing Width (in)	0.0	N/A	DWS Contrast?	N/A
N/A	Landing Slope (%)	0.0	N/A	DWS Length (in)	N/A
N/A	Landing X Slope (%)	0.0	N/A	DWS Full Width?	N/A
N/A	Landing Curb? (Y/N)	N/A	N/A	DWS Offset LT (in)	N/A
N/A	Shared Landing?	N/A	N/A	DWS Offset RT (in)	N/A
N/A	Gutter Ponding?	0.0	N/A	Gutter Slope (%)	N/A
N/A	Gutter Lip Ht (in)	0.0	N/A	Gutter X Slope (%)	N/A
N/A	Painted X Walk1?	No		Road Slope (%)	0.9
	X Walk 1 Direction	To W		Road X Slope (%)	2.1
	X Walk 1 Width (in)	N/A		Clear Space?	N/A

X Walk 1 Slope (%)	0.9	N/A	Clear Space to XWalk (in)	N/A
	X Walk 1 X Slope (%)	2.1	N/A	Storm Grate/Utility Hazard?	N/A
N/A	Ramp inside XWalk1?	N/A		Storm Grate/Utility Type	
N/A	Any Obstructions?	N/A			N/A
	Obstruction Type		Yes	Surface Condition? (G/P)	Good
			N/A	Curb Slope (%)	16.0

Remove & Replace Entire Ramp.
