Access Compliance Report

Public Rights-of-Way

(Curb Ramps)

Intersection ID: 24455	Main Street: S_TRYON_ST	Cross Street: STEELE_CREEK_RD	Location: NW
ADA ID: BAEC7EE59715	Ramp Type: Perp	Initial Pass/Fail: Fail	Overall Compliance: No
		Severity Score: 12.5

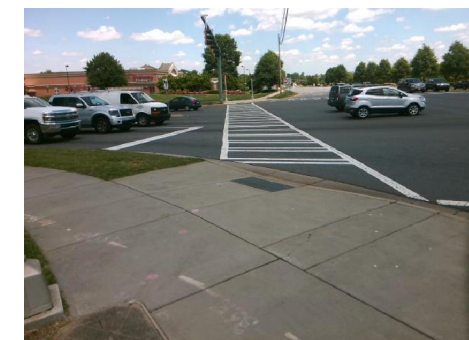
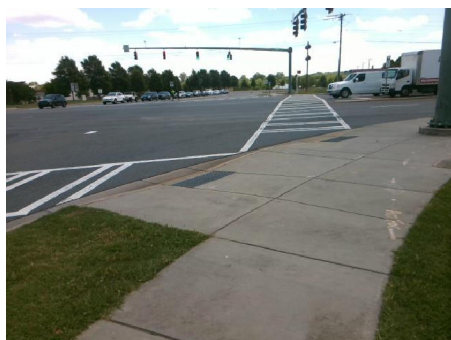
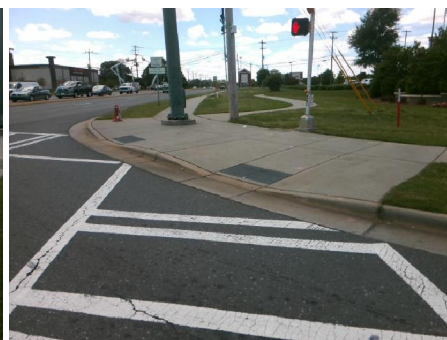
Compliance	Description	Data	Compliance	Description	Data
N/A	Ramp Length (in)	96.0	No	Ramp Slope (%)	9.1
Yes	Ramp Width (in)	48.0	Yes	Ramp XSlope (%)	1.9
N/A	Flare Type LT	N/A	N/A	Flare Type RT	N/A
N/A	Flare Slope LT (%)	N/A	N/A	Flare Slope RT (%)	N/A
N/A	Flare Traversable LT?	N/A	N/A	Flare Traversable RT?	N/A
N/A	Landing Length (in)	N/A	N/A	DWS Provided?	N/A
N/A	Landing Width (in)	N/A	N/A	DWS Contrast?	N/A
N/A	Landing Slope (%)	N/A	N/A	DWS Length (in)	N/A
N/A	Landing X Slope (%)	N/A	N/A	DWS Full Width?	N/A
N/A	Landing Curb? (Y/N)	N/A	N/A	DWS Offset (in)	N/A
N/A	Shared Landing?	N/A			
N/A	Gutter Ponding?	N/A	N/A	Gutter Slope (%)	N/A
N/A	Gutter Lip Ht (in)	N/A	N/A	Gutter X Slope (%)	N/A
N/A	Painted X Walk1?	Yes	N/A	Painted X Walk2?	N/A
	X Walk 1 Direction	To NE		X Walk 2 Direction	N/A
N/A	X Walk 1 Width (in)	120.0	N/A	X Walk 2 Width (in)	N/A
	X Walk 1 Slope (%)	2.6		X Walk 2 Slope (%)	N/A
	X Walk 1 X Slope (%)	0.6		X Walk 2 X Slope (%)	N/A

N/A	Ramp inside XWalk1?	Yes	N/A	Ramp inside XWalk2?	N/A
	Road Slope (%)	N/A	N/A	Clear Space?	N/A
	Road X Slope (%)	N/A	N/A	Clear Space to XWalk (in)	N/A
N/A	Any Obstructions?	N/A	N/A	Storm Grate/Utility Hazard?	N/A
	Obstruction Type			Storm Grate/Utility Type	
		N/A			N/A
		Yes		Surface Condition? (G/P)	Good

Remove & Replace Entire Ramp.
