Access Compliance Report

Public Rights-of-Way

(Curb Ramps)

Intersection ID: 44455	Main Street: AMES_HOLLOW_RD	Cross Street: BUCKHORN_ST	Location: NE
ADA ID: BAF4CC4F8B76	Ramp Type: BlendTrans1	Initial Pass/Fail: Fail	Overall Compliance: No
		Severity Score: 8.75

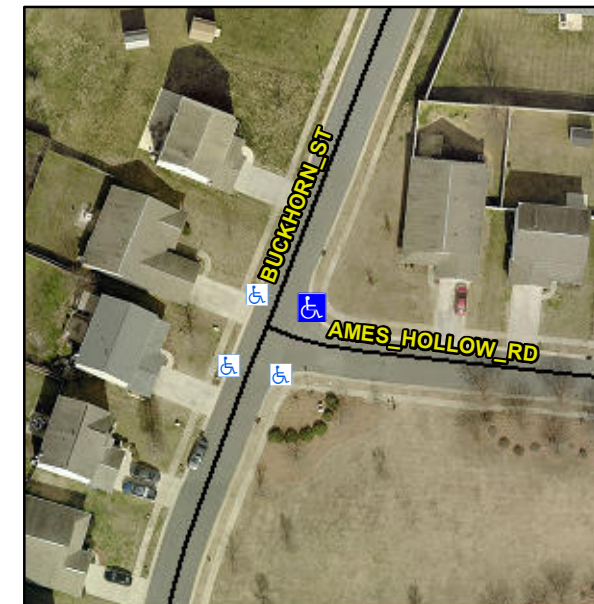
Not Found, R304.5.1

Compliance	Description	Data	Compliance	Description	Data
N/A	Ramp Length (in)	48.5	Yes	BlendTrans Slope (%)	3.9
No	Ramp Width (in)	38.0	Yes	BlendTrans XSlope (%)	1.8
N/A	Flare Type LT	N/A	N/A	Flare Type RT	N/A
N/A	Flare Slope LT (%)	N/A	N/A	Flare Slope RT (%)	N/A
N/A	Flare Traversable LT?	N/A	N/A	Flare Traversable RT?	N/A
N/A	Landing Length (in)	N/A	N/A	DWS Provided?	N/A
N/A	Landing Width (in)	N/A	N/A	DWS Contrast?	N/A
N/A	Landing Slope (%)	N/A	N/A	DWS Length (in)	N/A
N/A	Landing X Slope (%)	N/A	N/A	DWS Full Width?	N/A
N/A	Landing Curb? (Y/N)	N/A	N/A	DWS Offset (in)	N/A
N/A	Shared Landing?	N/A			
N/A	Gutter Ponding?	N/A	N/A	Gutter Slope (%)	N/A
N/A	Gutter Lip Ht (in)	N/A	N/A	Gutter X Slope (%)	N/A
N/A	Painted X Walk1?	No	N/A	Painted X Walk2?	No
	X Walk 1 Direction	To W		X Walk 2 Direction	To S
	X Walk 1 Width (in)	N/A		X Walk 2 Width (in)	N/A
	X Walk 1 Slope (%)	7.1		X Walk 2 Slope (%)	5.3
	X Walk 1 X Slope (%)	2.8		X Walk 2 X Slope (%)	1.8

N/A	Ramp inside XWalk1?	N/A	N/A	Ramp inside XWalk2?	N/A
	Road Slope (%)	0.8		Clear Space?	N/A
	Road X Slope (%)	5.6	N/A	Clear Space to XWalk (in)	N/A
N/A	Any Obstructions?	N/A	N/A	Storm Grate/Utility Hazard?	N/A
	Obstruction Type			Storm Grate/Utility Type	
		N/A			N/A
			Yes	Surface Condition? (G/P)	Good
			No	Curb Slope (%)	9.3

Remove & Replace Curb Ramp With Two New Directional Ramps or Equivalent.
