Access Compliance Report

Public Rights-of-Way

(Curb Ramps)

Intersection ID: 10016795	Main Street: HARRIS_STATION_BV	Cross Street: N/A	Location: SW
ADA ID: BAF9AE94A40E0	Ramp Type: Perp	Initial Pass/Fail: Fail	Overall Compliance: No
			Severity Score: 8.75

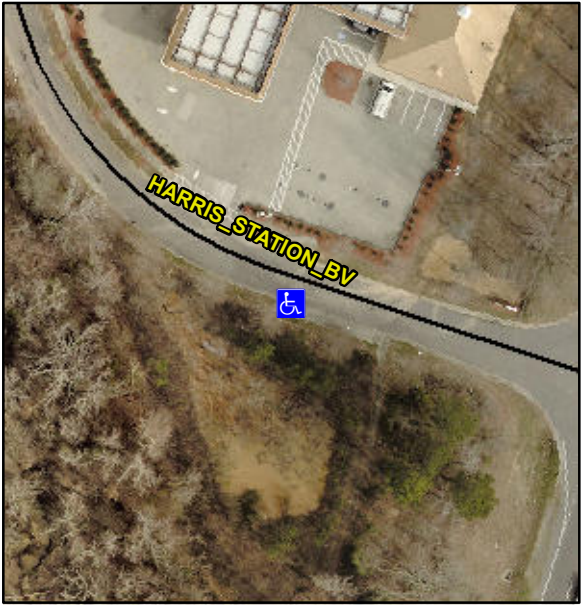
Possible Solutions:		Compliance	Description	Data
	Remove & Replace Entire Ramp.		N/A	Ramp Length (in)	72.0
			No	Ramp Width (in)	47.0
			N/A	Flare Type LT	N/A
			N/A	Flare Slope LT (%)	N/A
			N/A	Flare Traversable LT?	N/A
			N/A	Landing Length (in)	N/A
			N/A	Landing Width (in)	N/A
			N/A	Landing Slope (%)	N/A
			N/A	Landing X Slope (%)	N/A
<p>Surveyor Notes:</p> <p>N/A</p> <p>PROW/ADA:</p> <p>Not Found, R304.5.1</p>			N/A	Flare Type RT	N/A
			N/A	Flare Slope RT (%)	N/A
			N/A	Flare Traversable RT?	N/A
			N/A	DWS Provided?	N/A
			N/A	DWS Contrast?	N/A
			N/A	DWS Length (in)	N/A
			N/A	DWS Full Width?	N/A
			N/A	DWS Offset (in)	N/A
			N/A	Gutter Ponding?	N/A
			N/A	Gutter Lip Ht (in)	N/A
			N/A	Painted X Walk1?	No
				X Walk 1 Direction	To NE
			N/A	X Walk 1 Width (in)	N/A
				X Walk 1 Slope (%)	0.9
				X Walk 1 X Slope (%)	2.2

N/A	Ramp inside XWalk1?	N/A
			N/A	Ramp inside XWalk2?	N/A
			N/A	Road Slope (%)	N/A
			N/A	Road X Slope (%)	N/A
			N/A	Any Obstructions?	N/A
				Obstruction Type	
Total Cost:		\$ 1850.00			
			N/A		N/A
			Yes	Surface Condition? (G/P)	Good
