Access Compliance Report Public Rights-of-Way (Curb Ramps)

Intersection ID: N/AMain Street: STEELE_CREEK_RDCross Street: RACHEL_FREEMAN_WYLocation:SWADA ID: BB02A2F99B8BRamp Type: PerpDiagInitial Pass/Fail: FailOverall Compliance: NoSeverity Score:12.5

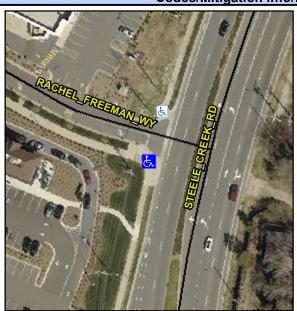
Not Found, R304.5.3

Field Measurements/Component Compnance						
	Compliance Description		Data	Compliance Description		Data
	N/A	Ramp Length (in)	72.0	Yes	Ramp Slope (%)	5.3
	Yes	Ramp Width (in)	48.0	No	Ramp XSlope (%)	5.5
	N/A	Flare Type LT	N/A	N/A	Flare Type RT	N/A
	N/A	Flare Slope LT (%)	N/A	N/A	Flare Slope RT (%)	N/A
	N/A	Flare Traversable LT?	N/A	N/A	Flare Traversable RT?	N/A
	N/A	Landing Length (in)	N/A	N/A	DWS Provided?	N/A
	N/A	Landing Width (in)	N/A	N/A	DWS Contrast?	N/A
	N/A	Landing Slope (%)	N/A	N/A	DWS Length (in)	N/A
	N/A	Landing X Slope (%)	N/A	N/A	DWS Full Width?	N/A
	N/A	Landing Curb? (Y/N)	N/A	N/A	DWS Offset (in)	N/A
	N/A	Shared Landing?	N/A			
	N/A	Gutter Ponding?	N/A	N/A	Gutter Slope (%)	N/A
	N/A	Gutter Lip Ht (in)	N/A	N/A	Gutter X Slope (%)	N/A
	N/A	Painted X Walk1?	No	N/A	Painted X Walk2?	No
		X Walk 1 Direction	To SE		X Walk 2 Direction	To NE
	N/A	X Walk 1 Width (in)	N/A	N/A	X Walk 2 Width (in)	N/A
		X Walk 1 Slope (%)	2.7		X Walk 2 Slope (%)	0.6

X Walk 1 X Slope (%)	0.1		X Walk 2 X Slope (%)	1.3
	N/A	Ramp inside XWalk1?	N/A	N/A	Ramp inside XWalk2?	N/A
		Road Slope (%)	3.4	N/A	Clear Space?	N/A
		Road X Slope (%)	0.7	N/A	Clear Space to XWalk (in)	N/A

Remove & Replace Curb Ramp With
Two New Directional Ramps or
Equivalent.
