Access Compliance Report

Public Rights-of-Way

(Curb Ramps)

Intersection ID: 31534	Main Street: ALMORA_DR	Cross Street: SUNMAN_RD	Location:	N
ADA ID: BB02DA9F150A	Ramp Type: BlendTrans1	Initial Pass/Fail: Fail	Overall Compliance: No	Severity Score: 10
Codes/Mitigation Info/Possible Solution		Field Measurements/Component Compliance

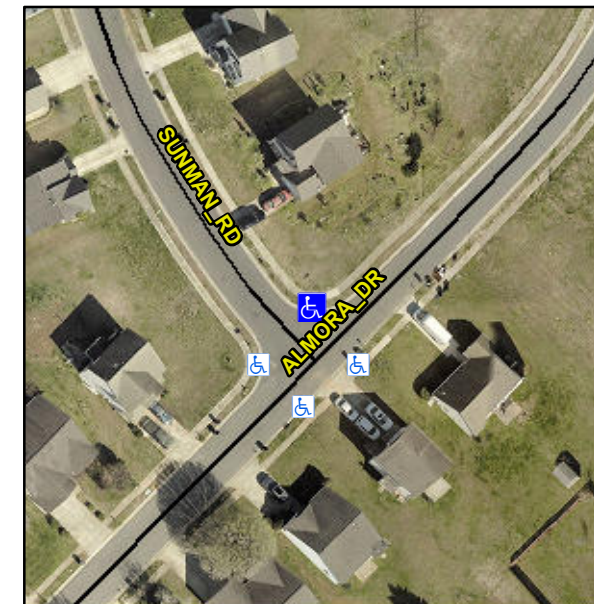
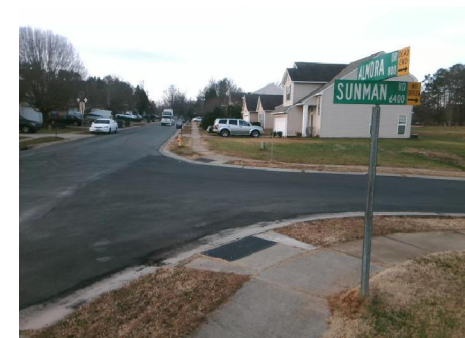
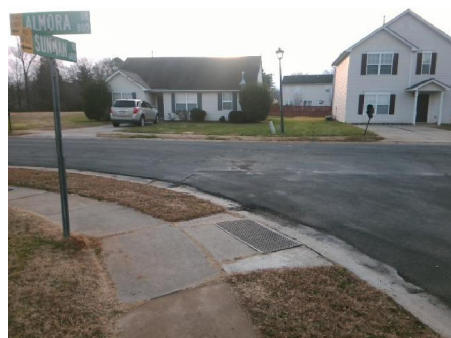
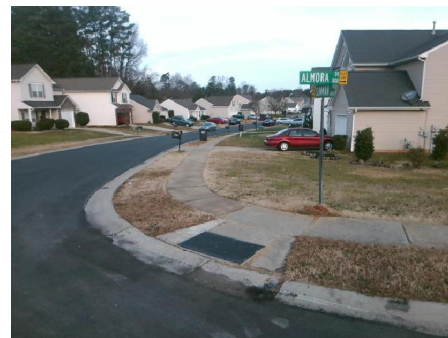
Not Found, R304.5.1, R304.5.3

Compliance	Description	Data	Compliance	Description	Data
N/A	Ramp Length (in)	48.0	Yes	BlendTrans Slope (%)	2.0
No	Ramp Width (in)	46.0	No	BlendTrans XSlope (%)	2.6
N/A	Flare Type LT	N/A	N/A	Flare Type RT	N/A
N/A	Flare Slope LT (%)	N/A	N/A	Flare Slope RT (%)	N/A
N/A	Flare Traversable LT?	N/A	N/A	Flare Traversable RT?	N/A
N/A	Landing Length (in)	N/A	N/A	DWS Provided?	N/A
N/A	Landing Width (in)	N/A	N/A	DWS Contrast?	N/A
N/A	Landing Slope (%)	N/A	N/A	DWS Length (in)	N/A
N/A	Landing X Slope (%)	N/A	N/A	DWS Full Width?	N/A
N/A	Landing Curb? (Y/N)	N/A	N/A	DWS Offset (in)	N/A
N/A	Shared Landing?	N/A			
N/A	Gutter Ponding?	N/A	N/A	Gutter Slope (%)	N/A
N/A	Gutter Lip Ht (in)	1.5	N/A	Gutter X Slope (%)	N/A
N/A	Painted X Walk1?	No	N/A	Painted X Walk2?	No
	X Walk 1 Direction	To SW		X Walk 2 Direction	To SE
	X Walk 1 Width (in)	N/A		X Walk 2 Width (in)	N/A
	X Walk 1 Slope (%)	2.7		X Walk 2 Slope (%)	8.2
	X Walk 1 X Slope (%)	4.7		X Walk 2 X Slope (%)	1.7

N/A	Ramp inside XWalk1?	N/A	N/A	Ramp inside XWalk2?	N/A
	Road Slope (%)	4.8		Clear Space?	N/A
	Road X Slope (%)	6.5	N/A	Clear Space to XWalk (in)	N/A
N/A	Any Obstructions?	N/A	N/A	Storm Grate/Utility Hazard?	N/A
	Obstruction Type			Storm Grate/Utility Type	
		N/A			N/A
			Yes	Surface Condition? (G/P)	Good
			No	Curb Slope (%)	21.3

Remove & Replace Curb Ramp With Two New Directional Ramps or Equivalent.
