# Access Compliance Report

## Public Rights-of-Way

### (Curb Ramps)

| Intersection ID: 28077 | Main Street: PROVIDENCE_RD_WEST | Cross Street: TOLLIVER_DR | Location: NE |

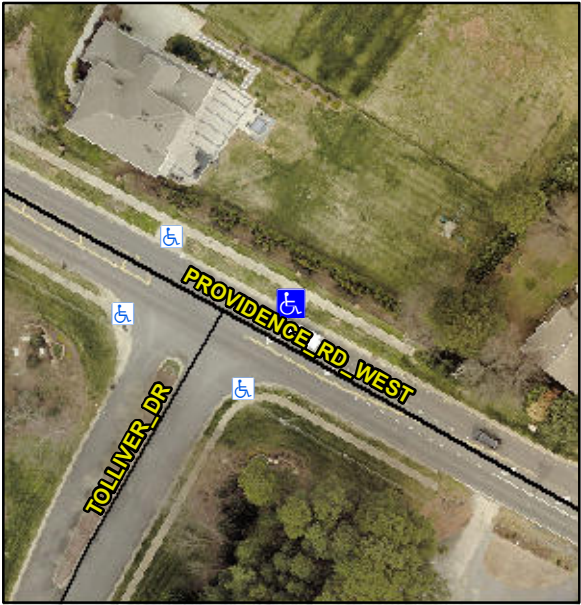
| ADA ID: BB05F371CA3F | Ramp Type: Perp | Initial Pass/Fail: Fail | Overall Compliance: No |
| Severity Score: 21.25 | | | |

| | | N/A | Ramp Length (in) | 96.0 | No | Ramp Slope (%) | 8.7 |
| | | No | Ramp Width (in) | 47.0 | Yes | Ramp XSlope (%) | 0.5 |
| <p>Surveyor Notes:</p> <p>N/A</p> <p>PROW/ADA:</p> <p>R304.5.1, R304.2.2</p> | | N/A | Landing X Slope (%) | N/A | N/A | DWS Full Width? | N/A |

| | Possible Solutions: | | | | | | |
| | Remove & Replace Entire Ramp. | Compliance | Description | Data | Compliance | Description | Data |
| Total Cost: | | \$ | 1850.00 | | | | |
