Access Compliance Report

Public Rights-of-Way

(Curb Ramps)

Intersection ID: 22059	Main Street: RICHARD_BARRY_DR	Cross Street: SARDIS_FOREST_DR	Location: NW
ADA ID: BB0BEB2DA34A	Ramp Type: Perp	Initial Pass/Fail: Fail	Overall Compliance: No
Severity Score: 37.5			
Codes/Mitigation Info/Possible Solution		Field Measurements/Component Compliance

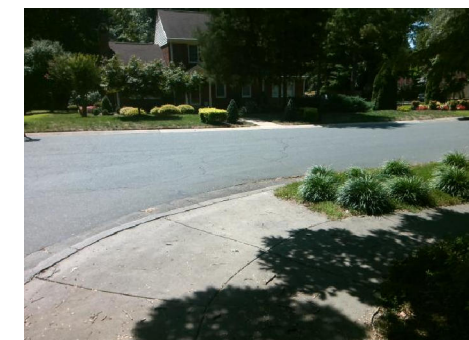
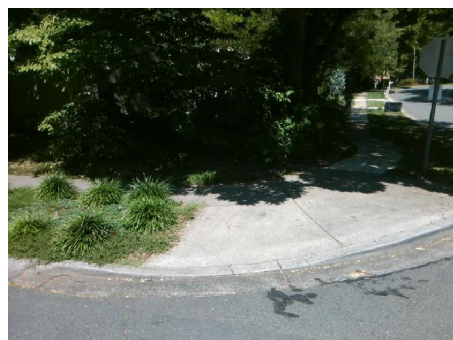
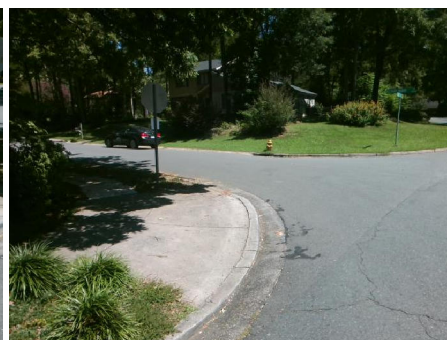
Compliance	Description	Data	Compliance	Description	Data
N/A	Ramp Length (in)	76.0	No	Ramp Slope (%)	9.0
Yes	Ramp Width (in)	48.0	No	Ramp XSlope (%)	8.7
N/A	Flare Type LT	N/A	N/A	Flare Type RT	N/A
N/A	Flare Slope LT (%)	N/A	N/A	Flare Slope RT (%)	N/A
N/A	Flare Traversable LT?	N/A	N/A	Flare Traversable RT?	N/A
N/A	Landing Length (in)	N/A	N/A	DWS Provided?	N/A
N/A	Landing Width (in)	N/A	N/A	DWS Contrast?	N/A
N/A	Landing Slope (%)	N/A	N/A	DWS Length (in)	N/A
N/A	Landing X Slope (%)	N/A	N/A	DWS Full Width?	N/A
N/A	Landing Curb? (Y/N)	N/A	N/A	DWS Offset (in)	N/A
N/A	Shared Landing?	N/A			
N/A	Gutter Ponding?	N/A	N/A	Gutter Slope (%)	N/A
N/A	Gutter Lip Ht (in)	N/A	N/A	Gutter X Slope (%)	N/A
N/A	Painted X Walk1?	No	N/A	Painted X Walk2?	N/A
	X Walk 1 Direction	To SE		X Walk 2 Direction	N/A
N/A	X Walk 1 Width (in)	N/A	N/A	X Walk 2 Width (in)	N/A
	X Walk 1 Slope (%)	1.4		X Walk 2 Slope (%)	N/A
	X Walk 1 X Slope (%)	1.6		X Walk 2 X Slope (%)	N/A

N/A	Ramp inside XWalk1?	N/A	N/A	Ramp inside XWalk2?	N/A
	Road Slope (%)	N/A	N/A	Clear Space?	N/A
	Road X Slope (%)	N/A	N/A	Clear Space to XWalk (in)	N/A
N/A	Any Obstructions?	N/A	N/A	Storm Grate/Utility Hazard?	N/A
	Obstruction Type			Storm Grate/Utility Type	
		N/A			N/A
			Yes	Surface Condition? (G/P)	Good

Remove & Replace Entire Ramp.
