# Access Compliance Report

## Public Rights-of-Way

### (Curb Ramps)

Intersection ID: 10020649	Main Street: BAYSE_CT	Cross Street: N/A	Location: NE
ADA ID: BB111A3BA31F	Ramp Type: Perp	Initial Pass/Fail: Pass	Overall Compliance: No
			Severity Score: 20.25

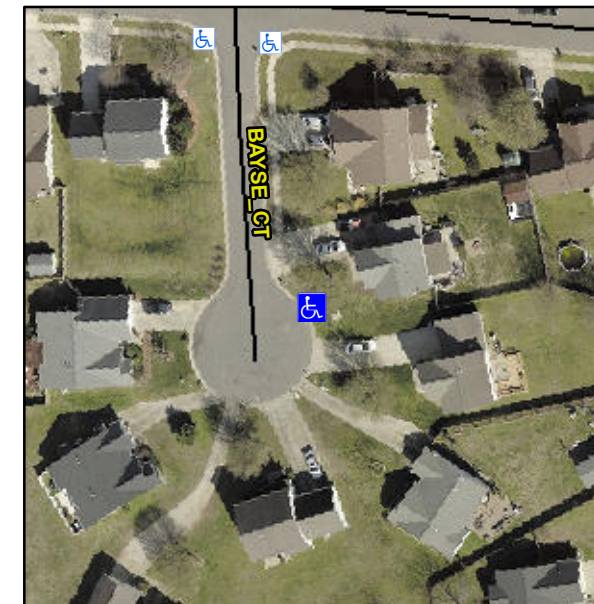
Compliance	Description	Data	Compliance	Description	Data
N/A	Ramp Length (in)	50.0	Yes	Ramp Slope (%)	6.4
Yes	Ramp Width (in)	48.0	No	Ramp XSlope (%)	2.1
N/A	Flare Type LT	Sloped	N/A	Flare Type RT	N/A
N/A	Flare Slope LT (%)	13.6	N/A	Flare Slope RT (%)	9.0
N/A	Flare Traversable LT?	Yes	N/A	Flare Traversable RT?	No
No	Landing Length (in)	47.0	No	DWS Provided?	No
Yes	Landing Width (in)	48.0	N/A	DWS Contrast?	No
No	Landing Slope (%)	3.2	N/A	DWS Length (in)	N/A
Yes	Landing X Slope (%)	1.3	N/A	DWS Full Width?	No
N/A	Landing Curb? (Y/N)	No	N/A	DWS Offset (in)	N/A
N/A	Shared Landing?	No			
Yes	Gutter Ponding?	No	No	Gutter Slope (%)	9.3
Yes	Gutter Lip Ht (in)	0.0	Yes	Gutter X Slope (%)	0.4
N/A	Painted X Walk1?	No	N/A	Painted X Walk2?	N/A
	X Walk 1 Direction	To SW		X Walk 2 Direction	N/A
N/A	X Walk 1 Width (in)	N/A	N/A	X Walk 2 Width (in)	N/A
	X Walk 1 Slope (%)	1.2		X Walk 2 Slope (%)	N/A
	X Walk 1 X Slope (%)	0.8		X Walk 2 X Slope (%)	N/A

N/A	Ramp inside XWalk1?	N/A	N/A	Ramp inside XWalk2?	N/A
	Road Slope (%)	N/A	N/A	Clear Space?	Yes
	Road X Slope (%)	N/A	N/A	Clear Space to XWalk (in)	N/A
Yes	Any Obstructions?	No	Yes	Storm Grate/Utility Hazard?	No
	Obstruction Type			Storm Grate/Utility Type	
		N/A			N/A
			Yes	Surface Condition? (G/P)	Good

**Remove & Replace Entire Ramp.  
Remove & Replace Gutter.**
