Access Compliance Report

Public Rights-of-Way

(Curb Ramps)

Intersection ID: 15561	Main Street: CUTLER_PL	Cross Street: PIERSON_DR	Location:	E
ADA ID: BB16E5689F12	Ramp Type: Perp	Initial Pass/Fail: Fail	Overall Compliance: No	Severity Score: 22.5
Codes/Mitigation Info/Possible Solution		Field Measurements/Component Compliance

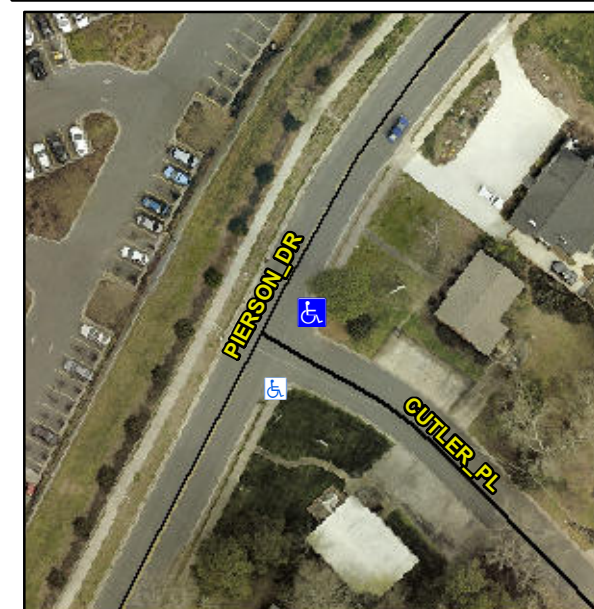
Not Found, R304.5.1, R304.2.2, R304.5.3

Compliance	Description	Data	Compliance	Description	Data
N/A	Ramp Length (in)	58.0	No	Ramp Slope (%)	9.8
No	Ramp Width (in)	39.5	No	Ramp XSlope (%)	3.0
N/A	Flare Type LT	N/A	N/A	Flare Type RT	N/A
N/A	Flare Slope LT (%)	N/A	N/A	Flare Slope RT (%)	N/A
N/A	Flare Traversable LT?	N/A	N/A	Flare Traversable RT?	N/A
N/A	Landing Length (in)	N/A	N/A	DWS Provided?	N/A
N/A	Landing Width (in)	N/A	N/A	DWS Contrast?	N/A
N/A	Landing Slope (%)	N/A	N/A	DWS Length (in)	N/A
N/A	Landing X Slope (%)	N/A	N/A	DWS Full Width?	N/A
N/A	Landing Curb? (Y/N)	N/A	N/A	DWS Offset (in)	N/A
N/A	Shared Landing?	N/A			
N/A	Gutter Ponding?	N/A	N/A	Gutter Slope (%)	N/A
N/A	Gutter Lip Ht (in)	N/A	N/A	Gutter X Slope (%)	N/A
N/A	Painted X Walk1?	No	N/A	Painted X Walk2?	N/A
	X Walk 1 Direction	To SW		X Walk 2 Direction	N/A
N/A	X Walk 1 Width (in)	N/A	N/A	X Walk 2 Width (in)	N/A
	X Walk 1 Slope (%)	3.4		X Walk 2 Slope (%)	N/A
	X Walk 1 X Slope (%)	0.9		X Walk 2 X Slope (%)	N/A

Remove & Replace Entire Ramp.
