# Access Compliance Report

## Public Rights-of-Way

### (Curb Ramps)

Intersection ID: 28061	Main Street: CORRYSTONE_DR	Cross Street: WILLOW_ROCK_DR	Location: W
ADA ID: BB1711CD07AD	Ramp Type: PerpDiag	Initial Pass/Fail: Fail	Overall Compliance: No
Severity Score: 42.5			
Codes/Mitigation Info/Possible Solution		Field Measurements/Component Compliance

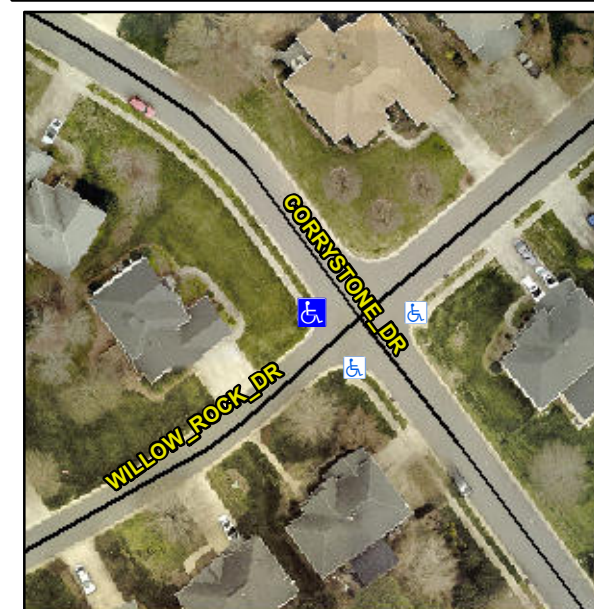
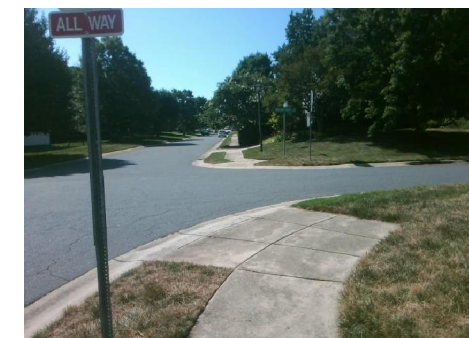
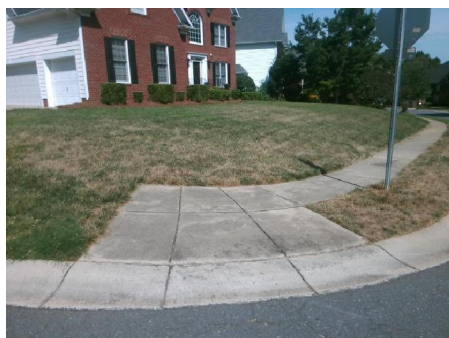
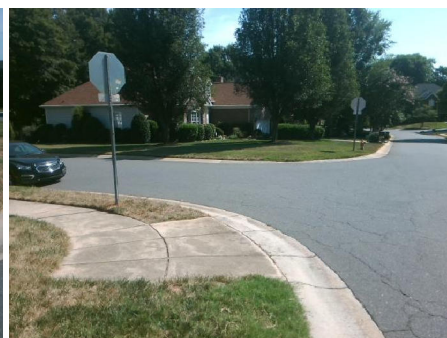
**Not Found, R304.5.1, R304.5.3**

Compliance	Description	Data	Compliance	Description	Data
N/A	Ramp Length (in)	48.0	Yes	Ramp Slope (%)	7.6
No	Ramp Width (in)	33.0	No	Ramp XSlope (%)	8.6
N/A	Flare Type LT	N/A	N/A	Flare Type RT	N/A
N/A	Flare Slope LT (%)	N/A	N/A	Flare Slope RT (%)	N/A
N/A	Flare Traversable LT?	N/A	N/A	Flare Traversable RT?	N/A
N/A	Landing Length (in)	N/A	N/A	DWS Provided?	N/A
N/A	Landing Width (in)	N/A	N/A	DWS Contrast?	N/A
N/A	Landing Slope (%)	N/A	N/A	DWS Length (in)	N/A
N/A	Landing X Slope (%)	N/A	N/A	DWS Full Width?	N/A
N/A	Landing Curb? (Y/N)	N/A	N/A	DWS Offset (in)	N/A
N/A	Shared Landing?	N/A			
N/A	Gutter Ponding?	N/A	N/A	Gutter Slope (%)	N/A
N/A	Gutter Lip Ht (in)	N/A	N/A	Gutter X Slope (%)	N/A
N/A	Painted X Walk1?	No	N/A	Painted X Walk2?	No
	X Walk 1 Direction	To SE		X Walk 2 Direction	To NE
N/A	X Walk 1 Width (in)	N/A	N/A	X Walk 2 Width (in)	N/A
	X Walk 1 Slope (%)	1.1		X Walk 2 Slope (%)	2.9
	X Walk 1 X Slope (%)	3.8		X Walk 2 X Slope (%)	2.4

N/A	Ramp inside XWalk1?	N/A	N/A	Ramp inside XWalk2?	N/A
	Road Slope (%)	5.3	N/A	Clear Space?	N/A
	Road X Slope (%)	0.2	N/A	Clear Space to XWalk (in)	N/A
N/A	Any Obstructions?	N/A	N/A	Storm Grate/Utility Hazard?	N/A
	Obstruction Type			Storm Grate/Utility Type	
		N/A			N/A
			Yes	Surface Condition? (G/P)	Good

**Remove & Replace Curb Ramp With Two New Directional Ramps or Equivalent.**
