# Access Compliance Report

## Public Rights-of-Way

### (Curb Ramps)

Intersection ID: 10751	Main Street: STATESVILLE_AV	Cross Street: OLIVER_ST	Location: SW
ADA ID: BB1D0EB08FFE	Ramp Type: Perp	Initial Pass/Fail: Fail	Overall Compliance: No
Severity Score: 22.5			
Codes/Mitigation Info/Possible Solution		Field Measurements/Component Compliance

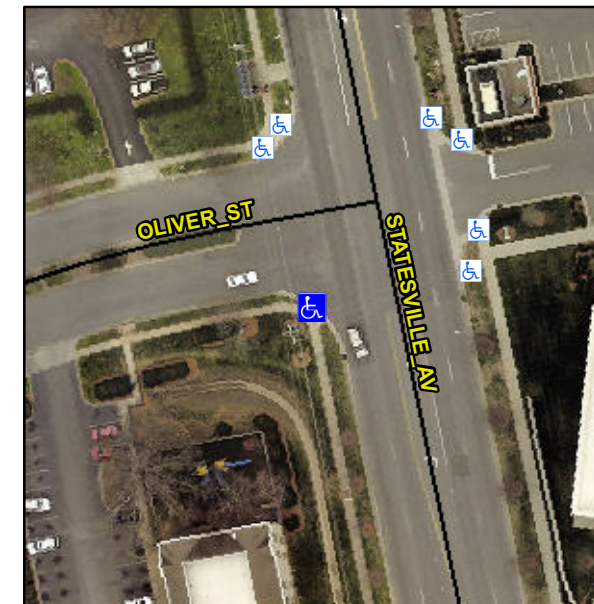
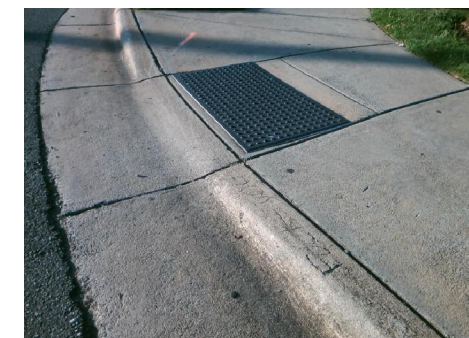
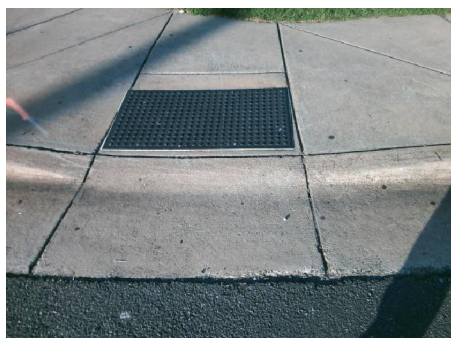
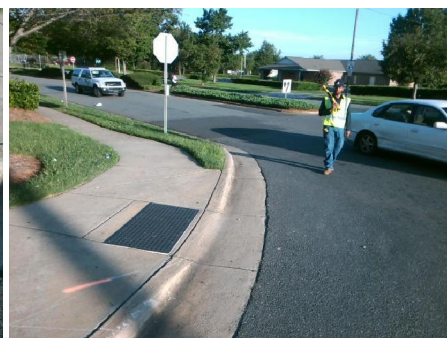
**Not Found, R304.5.1, R304.2.2, R304.5.3**

Compliance	Description	Data	Compliance	Description	Data
N/A	Ramp Length (in)	35.5	No	Ramp Slope (%)	9.5
No	Ramp Width (in)	44.5	No	Ramp XSlope (%)	2.2
N/A	Flare Type LT	N/A	N/A	Flare Type RT	N/A
N/A	Flare Slope LT (%)	N/A	N/A	Flare Slope RT (%)	N/A
N/A	Flare Traversable LT?	N/A	N/A	Flare Traversable RT?	N/A
N/A	Landing Length (in)	N/A	N/A	DWS Provided?	N/A
N/A	Landing Width (in)	N/A	N/A	DWS Contrast?	N/A
N/A	Landing Slope (%)	N/A	N/A	DWS Length (in)	N/A
N/A	Landing X Slope (%)	N/A	N/A	DWS Full Width?	N/A
N/A	Landing Curb? (Y/N)	N/A	N/A	DWS Offset (in)	N/A
N/A	Shared Landing?	N/A			
N/A	Gutter Ponding?	N/A	N/A	Gutter Slope (%)	N/A
N/A	Gutter Lip Ht (in)	0.5	N/A	Gutter X Slope (%)	N/A
N/A	Painted X Walk1?	No	N/A	Painted X Walk2?	N/A
	X Walk 1 Direction	To N		X Walk 2 Direction	N/A
N/A	X Walk 1 Width (in)	N/A	N/A	X Walk 2 Width (in)	N/A
	X Walk 1 Slope (%)	2.8		X Walk 2 Slope (%)	N/A
	X Walk 1 X Slope (%)	1.9		X Walk 2 X Slope (%)	N/A

N/A	Ramp inside XWalk1?	N/A	N/A	Ramp inside XWalk2?	N/A
	Road Slope (%)	N/A	N/A	Clear Space?	N/A
	Road X Slope (%)	N/A	N/A	Clear Space to XWalk (in)	N/A
N/A	Any Obstructions?	N/A	N/A	Storm Grate/Utility Hazard?	N/A
	Obstruction Type			Storm Grate/Utility Type	
		N/A			N/A
			Yes	Surface Condition? (G/P)	Good

**Remove & Replace Entire Ramp.**

Total Cost: \$ 1850.00
