Access Compliance Report

Public Rights-of-Way

(Curb Ramps)

Intersection ID: 10022586	Main Street: CARMEL_RD	Cross Street: N/A	Location: NW
ADA ID: BB23758F0418	Ramp Type: PerpDiag	Initial Pass/Fail: Fail	Overall Compliance: No
		Severity Score: 25

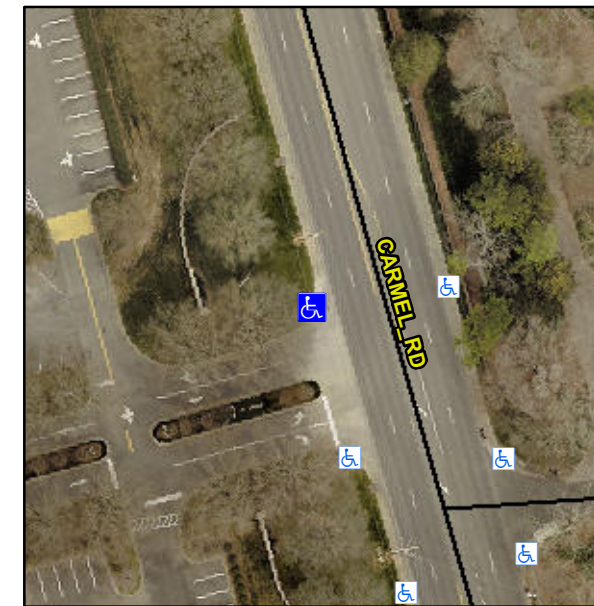
Compliance	Description	Data	Compliance	Description	Data
N/A	Ramp Length (in)	50.0	No	Ramp Slope (%)	13.0
Yes	Ramp Width (in)	48.0	Yes	Ramp XSlope (%)	0.1
N/A	Flare Type LT	N/A	N/A	Flare Type RT	N/A
N/A	Flare Slope LT (%)	N/A	N/A	Flare Slope RT (%)	N/A
N/A	Flare Traversable LT?	N/A	N/A	Flare Traversable RT?	N/A
N/A	Landing Length (in)	N/A	N/A	DWS Provided?	N/A
N/A	Landing Width (in)	N/A	N/A	DWS Contrast?	N/A
N/A	Landing Slope (%)	N/A	N/A	DWS Length (in)	N/A
N/A	Landing X Slope (%)	N/A	N/A	DWS Full Width?	N/A
N/A	Landing Curb? (Y/N)	N/A	N/A	DWS Offset (in)	N/A
N/A	Shared Landing?	N/A			
N/A	Gutter Ponding?	N/A	N/A	Gutter Slope (%)	N/A
N/A	Gutter Lip Ht (in)	N/A	N/A	Gutter X Slope (%)	N/A
N/A	Painted X Walk1?	No	N/A	Painted X Walk2?	No
	X Walk 1 Direction	To S		X Walk 2 Direction	To E
N/A	X Walk 1 Width (in)	N/A	N/A	X Walk 2 Width (in)	N/A
	X Walk 1 Slope (%)	1.1		X Walk 2 Slope (%)	1.2
	X Walk 1 X Slope (%)	1.5		X Walk 2 X Slope (%)	1.3

N/A	Ramp inside XWalk1?	N/A	N/A	Ramp inside XWalk2?	N/A
	Road Slope (%)	2.0	N/A	Clear Space?	N/A
	Road X Slope (%)	0.9	N/A	Clear Space to XWalk (in)	N/A
N/A	Any Obstructions?	N/A	N/A	Storm Grate/Utility Hazard?	N/A
	Obstruction Type			Storm Grate/Utility Type	
		N/A			N/A
			Yes	Surface Condition? (G/P)	Good

Remove & Replace Curb Ramp With Two New Directional Ramps or Equivalent.
