# Access Compliance Report

## Public Rights-of-Way

Intersection ID: 11894	Main Street: N_BREVARD_ST	Cross Street: E_12TH_ST	Location: N
ADA ID: BB4043242B8D	Ramp Type: Perp	Initial Pass/Fail: Fail	Overall Compliance: No
Severity Score: 12.5			
Codes/Mitigation Info/Possible Solution		Field Measurements/Component Compliance

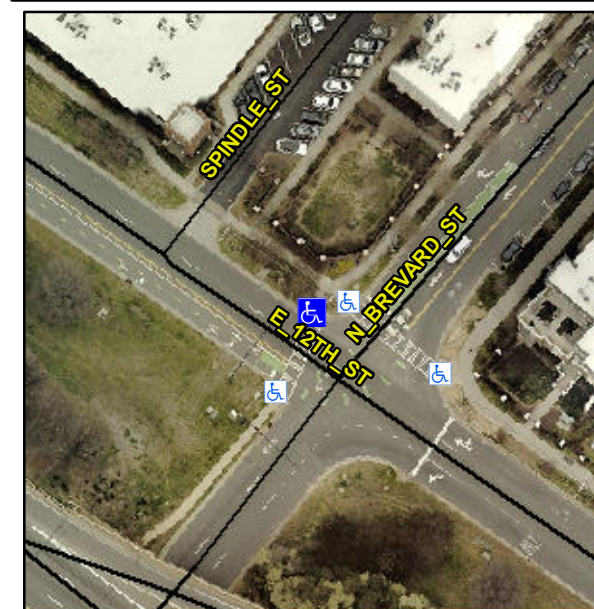
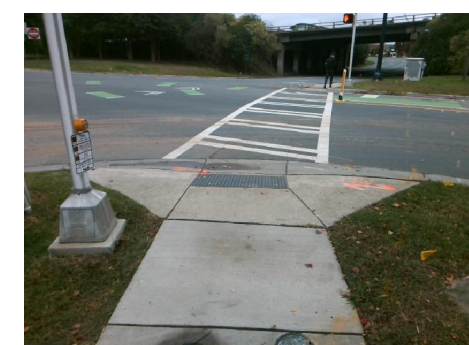
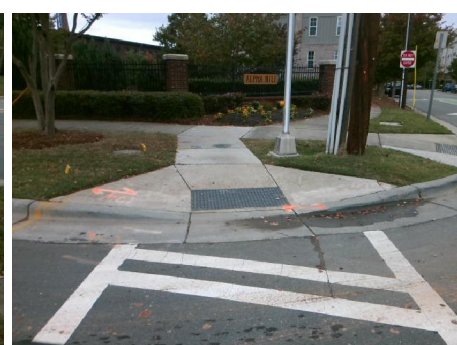
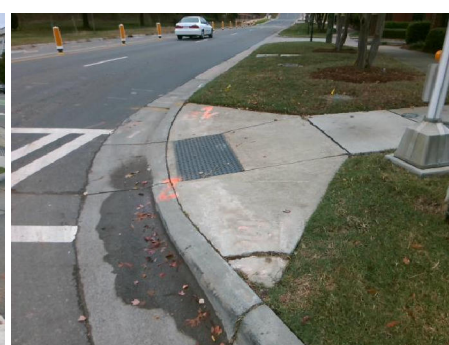
**Not Found, R304.2.2**

Compliance	Description	Data	Compliance	Description	Data
N/A	Ramp Length (in)	74.0	No	Ramp Slope (%)	8.7
Yes	Ramp Width (in)	48.0	Yes	Ramp XSlope (%)	0.3
N/A	Flare Type LT	N/A	N/A	Flare Type RT	N/A
N/A	Flare Slope LT (%)	N/A	N/A	Flare Slope RT (%)	N/A
N/A	Flare Traversable LT?	N/A	N/A	Flare Traversable RT?	N/A
N/A	Landing Length (in)	N/A	N/A	DWS Provided?	N/A
N/A	Landing Width (in)	N/A	N/A	DWS Contrast?	N/A
N/A	Landing Slope (%)	N/A	N/A	DWS Length (in)	N/A
N/A	Landing X Slope (%)	N/A	N/A	DWS Full Width?	N/A
N/A	Landing Curb? (Y/N)	N/A	N/A	DWS Offset (in)	N/A
N/A	Shared Landing?	N/A			
N/A	Gutter Ponding?	Yes	N/A	Gutter Slope (%)	N/A
N/A	Gutter Lip Ht (in)	N/A	N/A	Gutter X Slope (%)	N/A
N/A	Painted X Walk1?	Yes	N/A	Painted X Walk2?	N/A
	X Walk 1 Direction	To SW		X Walk 2 Direction	N/A
N/A	X Walk 1 Width (in)	87.0	N/A	X Walk 2 Width (in)	N/A
	X Walk 1 Slope (%)	3.5		X Walk 2 Slope (%)	N/A
	X Walk 1 X Slope (%)	0.6		X Walk 2 X Slope (%)	N/A

N/A	Ramp inside XWalk1?	Yes	N/A	Ramp inside XWalk2?	N/A
	Road Slope (%)	N/A	N/A	Clear Space?	N/A
	Road X Slope (%)	N/A	N/A	Clear Space to XWalk (in)	N/A
N/A	Any Obstructions?	N/A	N/A	Storm Grate/Utility Hazard?	N/A
	Obstruction Type			Storm Grate/Utility Type	
		N/A			N/A
		Yes	Yes	Surface Condition? (G/P)	Good

**Remove & Replace Entire Ramp.**
