# Access Compliance Report

## Public Rights-of-Way

### (Curb Ramps)

Intersection ID: 49151	Main Street: DACAVIN_DR	Cross Street: VIDAL_LN	Location: NE
ADA ID: BB4E29A72DAC	Ramp Type: Perp	Initial Pass/Fail: Fail	Overall Compliance: No
Severity Score: 33.75			
Codes/Mitigation Info/Possible Solution		Field Measurements/Component Compliance

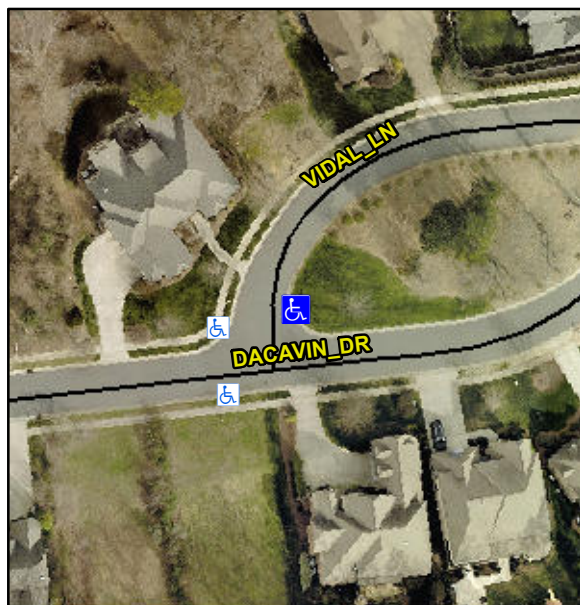
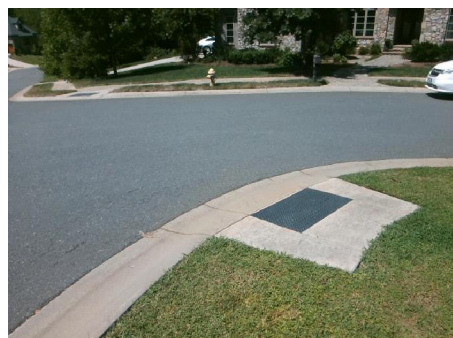
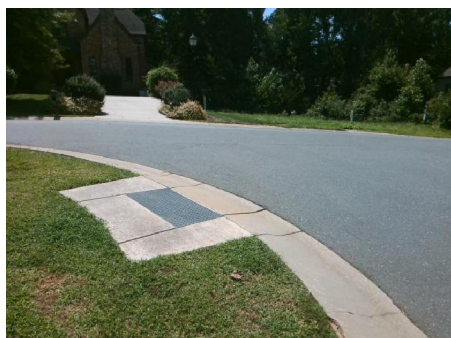
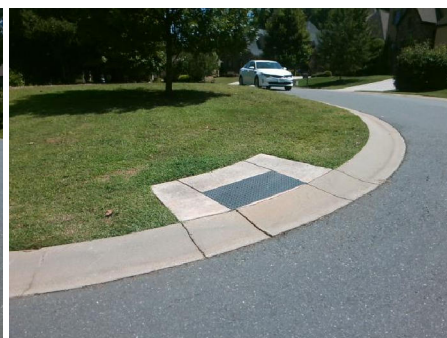
**Not Found, R304.5.1, R304.5.3**

Compliance	Description	Data	Compliance	Description	Data
N/A	Ramp Length (in)	48.0	Yes	Ramp Slope (%)	7.2
No	Ramp Width (in)	45.0	No	Ramp XSlope (%)	12.8
N/A	Flare Type LT	N/A	N/A	Flare Type RT	N/A
N/A	Flare Slope LT (%)	N/A	N/A	Flare Slope RT (%)	N/A
N/A	Flare Traversable LT?	N/A	N/A	Flare Traversable RT?	N/A
N/A	Landing Length (in)	N/A	N/A	DWS Provided?	N/A
N/A	Landing Width (in)	N/A	N/A	DWS Contrast?	N/A
N/A	Landing Slope (%)	N/A	N/A	DWS Length (in)	N/A
N/A	Landing X Slope (%)	N/A	N/A	DWS Full Width?	N/A
N/A	Landing Curb? (Y/N)	N/A	N/A	DWS Offset (in)	N/A
N/A	Shared Landing?	N/A			
N/A	Gutter Ponding?	N/A	N/A	Gutter Slope (%)	N/A
N/A	Gutter Lip Ht (in)	N/A	N/A	Gutter X Slope (%)	N/A
N/A	Painted X Walk1?	No	N/A	Painted X Walk2?	N/A
	X Walk 1 Direction	To W		X Walk 2 Direction	N/A
N/A	X Walk 1 Width (in)	N/A	N/A	X Walk 2 Width (in)	N/A
	X Walk 1 Slope (%)	3.8		X Walk 2 Slope (%)	N/A
	X Walk 1 X Slope (%)	8.5		X Walk 2 X Slope (%)	N/A

N/A	Ramp inside XWalk1?	N/A	N/A	Ramp inside XWalk2?	N/A
	Road Slope (%)	N/A	N/A	Clear Space?	N/A
	Road X Slope (%)	N/A	N/A	Clear Space to XWalk (in)	N/A
N/A	Any Obstructions?	N/A	N/A	Storm Grate/Utility Hazard?	N/A
	Obstruction Type			Storm Grate/Utility Type	
		N/A			N/A
			Yes	Surface Condition? (G/P)	Good

**Remove & Replace Entire Ramp.**
