Access Compliance Report

Public Rights-of-Way

(Curb Ramps)

Intersection ID: 13871	Main Street: E_5TH_ST	Cross Street: HAWTHORNE_LN	Location: S
ADA ID: BB4E6C0171D0	Ramp Type: PerpDiag	Initial Pass/Fail: Pass	Overall Compliance: No
			Severity Score: 10.25

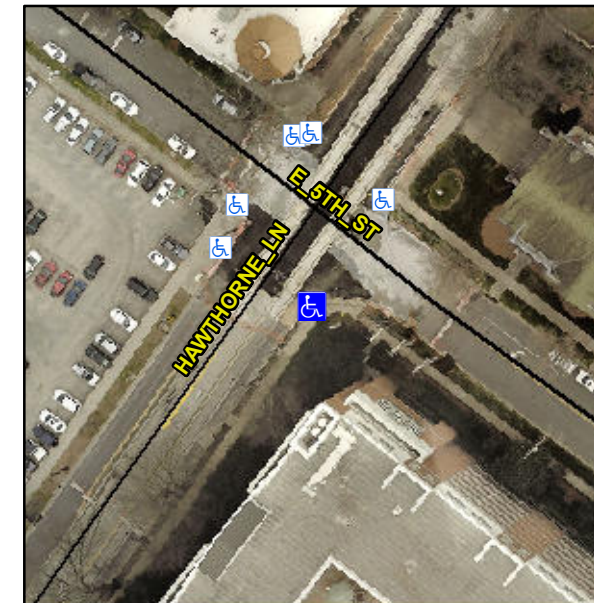
Not Found, R304.5.3, R304.2.1, R304.2.2-Perp, R304.3.2-Para, R305.2

Compliance	Description	Data	Compliance	Description	Data
N/A	Ramp Length (in)	60.0	Yes	Ramp Slope (%)	5.1
Yes	Ramp Width (in)	96.0	No	Ramp XSlope (%)	4.5
N/A	Flare Type LT	Sloped	N/A	Flare Type RT	N/A
N/A	Flare Slope LT (%)	5.5	Yes	Flare Slope RT (%)	5.8
N/A	Flare Traversable LT?	Yes	N/A	Flare Traversable RT?	Yes
No	Landing Length (in)	N/A	Yes	DWS Provided?	Yes
No	Landing Width (in)	N/A	Yes	DWS Contrast?	Yes
No	Landing Slope (%)	N/A	Yes	DWS Length (in)	24.5
No	Landing X Slope (%)	N/A	Yes	DWS Full Width?	Yes
N/A	Landing Curb? (Y/N)	No	No	DWS Offset (in)	3.5
N/A	Shared Landing?	N/A			
Yes	Gutter Ponding?	No	Yes	Gutter Slope (%)	3.1
Yes	Gutter Lip Ht (in)	0.0	Yes	Gutter X Slope (%)	0.0
N/A	Painted X Walk1?	Yes	N/A	Painted X Walk2?	Yes
	X Walk 1 Direction	To NE		X Walk 2 Direction	To NW
N/A	X Walk 1 Width (in)	122.0	N/A	X Walk 2 Width (in)	114.0
	X Walk 1 Slope (%)	3.5		X Walk 2 Slope (%)	1.3
	X Walk 1 X Slope (%)	1.1		X Walk 2 X Slope (%)	3.6

Yes	Ramp inside XWalk1?	Yes	Yes	Ramp inside XWalk2?	Yes
	Road Slope (%)	0.2	N/A	Clear Space?	Yes
	Road X Slope (%)	2.5	Yes	Clear Space to XWalk (in)	53.0
Yes	Any Obstructions?	No	Yes	Storm Grate/Utility Hazard?	No
	Obstruction Type			Storm Grate/Utility Type	
		N/A			N/A
			Yes	Surface Condition? (G/P)	Good

Remove & Replace Curb Ramp With Two New Directional Ramps or Equivalent.
