Access Compliance Report

Public Rights-of-Way

(Curb Ramps)

Intersection ID: 10024493	Main Street: CROWNPOINT_EXECUTIVE_DR	Cross Street: N/A	Location:	N
ADA ID: BB53F5DAD877	Ramp Type: PerpDiag	Initial Pass/Fail: Fail	Overall Compliance: No	Severity Score: 12.5
Codes/Mitigation Info/Possible Solution		Field Measurements/Component Compliance

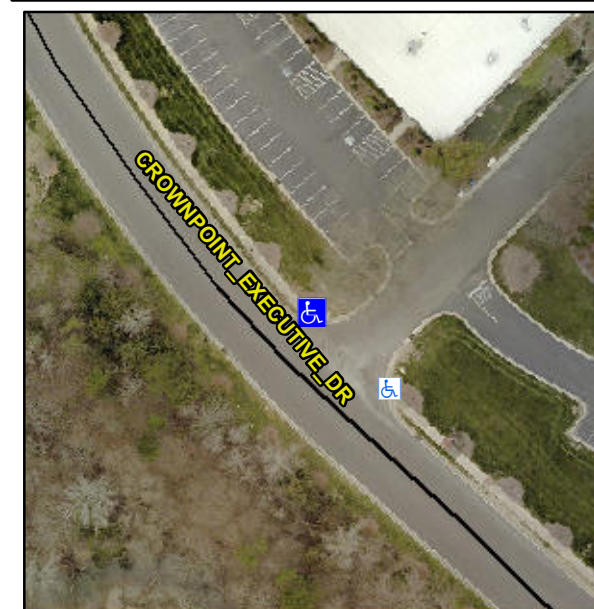
Compliance	Description	Data	Compliance	Description	Data
N/A	Ramp Length (in)	48.0	Yes	Ramp Slope (%)	6.6
Yes	Ramp Width (in)	48.0	No	Ramp XSlope (%)	5.4
N/A	Flare Type LT	N/A	N/A	Flare Type RT	N/A
N/A	Flare Slope LT (%)	N/A	N/A	Flare Slope RT (%)	N/A
N/A	Flare Traversable LT?	N/A	N/A	Flare Traversable RT?	N/A
N/A	Landing Length (in)	N/A	N/A	DWS Provided?	N/A
N/A	Landing Width (in)	N/A	N/A	DWS Contrast?	N/A
N/A	Landing Slope (%)	N/A	N/A	DWS Length (in)	N/A
N/A	Landing X Slope (%)	N/A	N/A	DWS Full Width?	N/A
N/A	Landing Curb? (Y/N)	N/A	N/A	DWS Offset (in)	N/A
N/A	Shared Landing?	N/A			
N/A	Gutter Ponding?	N/A	N/A	Gutter Slope (%)	N/A
N/A	Gutter Lip Ht (in)	N/A	N/A	Gutter X Slope (%)	N/A
N/A	Painted X Walk1?	No	N/A	Painted X Walk2?	No
	X Walk 1 Direction	To SW		X Walk 2 Direction	To SE
N/A	X Walk 1 Width (in)	N/A	N/A	X Walk 2 Width (in)	N/A
	X Walk 1 Slope (%)	0.7		X Walk 2 Slope (%)	0.2
	X Walk 1 X Slope (%)	1.2		X Walk 2 X Slope (%)	7.2

N/A	Ramp inside XWalk1?	N/A	N/A	Ramp inside XWalk2?	N/A
	Road Slope (%)	6.1	N/A	Clear Space?	N/A
	Road X Slope (%)	5.2	N/A	Clear Space to XWalk (in)	N/A
N/A	Any Obstructions?	N/A	N/A	Storm Grate/Utility Hazard?	N/A
	Obstruction Type			Storm Grate/Utility Type	
		N/A			N/A
		Yes		Surface Condition? (G/P)	Good

Possible Solutions:

Remove & Replace Curb Ramp With Two New Directional Ramps or Equivalent.
