0.5

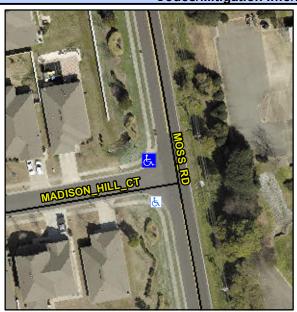
MADISON HILL CT Street 1 Name Stop Condition-Street 2 StopSign MOSS RD Street 2 Name Stop Condition-Street 1 None Possible Solutions: Remove & Replace Curb Ramp With Two New Directional Ramps or Equivalent. Surveyor Notes: N/A PROW/ADA: R304.2.2
