Access Compliance Report

Public Rights-of-Way

(Curb Ramps)

Intersection ID: 16451	Main Street: HARTFORD_AV	Cross Street: HOLLIS_RD	Location: NW
ADA ID: BB65CAFA5EAC	Ramp Type: Perp	Initial Pass/Fail: Fail	Overall Compliance: No
		Severity Score: 10

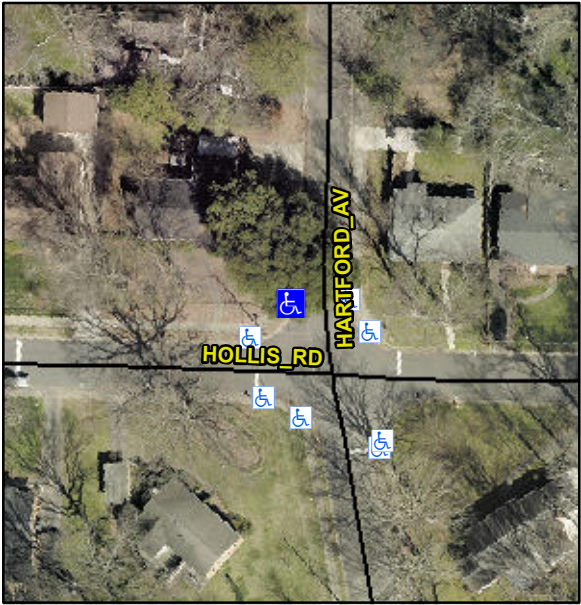
Possible Solutions:		Compliance	Description	Data	
	Remove & Replace Entire Ramp.		N/A	Ramp Length (in)	26.0	Yes
			No	Ramp Width (in)	41.0	No
			N/A	Flare Type LT	N/A	N/A
			N/A	Flare Slope LT (%)	N/A	N/A
			N/A	Flare Traversable LT?	N/A	N/A
			N/A	Landing Length (in)	N/A	N/A
			N/A	Landing Width (in)	N/A	N/A
			N/A	Landing Slope (%)	N/A	N/A
			N/A	Landing X Slope (%)	N/A	N/A
			N/A	Landing Curb? (Y/N)	N/A	N/A
			N/A	Shared Landing?	N/A	
			N/A	Gutter Ponding?	N/A	N/A
			N/A	Gutter Lip Ht (in)	N/A	N/A
			N/A	Painted X Walk1?	No	N/A
				X Walk 1 Direction	To E	N/A
			N/A	X Walk 1 Width (in)	N/A	N/A
				X Walk 1 Slope (%)	2.3	N/A
				X Walk 1 X Slope (%)	0.1	N/A
			N/A	Ramp inside XWalk1?	N/A	N/A
<p>Surveyor Notes:</p> <p>N/A</p> <p>PROW/ADA:</p> <p>Not Found, R304.5.1, R304.5.3</p>			N/A	Road Slope (%)	N/A	N/A
			N/A	Road X Slope (%)	N/A	N/A

N/A	Any Obstructions?	N/A	N/A
				Obstruction Type		
					N/A	N/A
			Yes	Surface Condition? (G/P)	Good	Good
Total Cost:		\$ 1850.00
