# Access Compliance Report

## Public Rights-of-Way

### (Curb Ramps)

Intersection ID: 15189	Main Street: DUNN_AV	Cross Street: ALPHA_ST	Location: SE
ADA ID: BB74939B2D0C	Ramp Type: PerpDiag	Initial Pass/Fail: Fail	Overall Compliance: No
Severity Score: 8.75			
Codes/Mitigation Info/Possible Solution		Field Measurements/Component Compliance

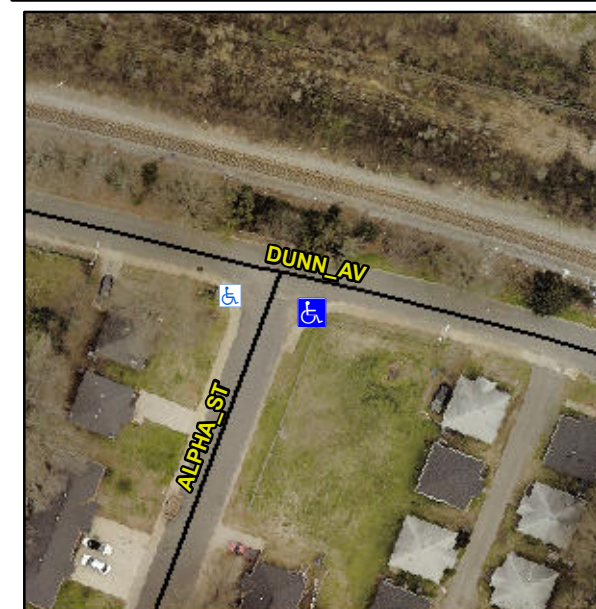
Compliance	Description	Data	Compliance	Description	Data
N/A	Ramp Length (in)	59.0	Yes	Ramp Slope (%)	5.4
No	Ramp Width (in)	38.0	Yes	Ramp XSlope (%)	0.3
N/A	Flare Type LT	N/A	N/A	Flare Type RT	N/A
N/A	Flare Slope LT (%)	N/A	N/A	Flare Slope RT (%)	N/A
N/A	Flare Traversable LT?	N/A	N/A	Flare Traversable RT?	N/A
N/A	Landing Length (in)	N/A	N/A	DWS Provided?	N/A
N/A	Landing Width (in)	N/A	N/A	DWS Contrast?	N/A
N/A	Landing Slope (%)	N/A	N/A	DWS Length (in)	N/A
N/A	Landing X Slope (%)	N/A	N/A	DWS Full Width?	N/A
N/A	Landing Curb? (Y/N)	N/A	N/A	DWS Offset (in)	N/A
N/A	Shared Landing?	N/A			
N/A	Gutter Ponding?	N/A	N/A	Gutter Slope (%)	N/A
N/A	Gutter Lip Ht (in)	N/A	N/A	Gutter X Slope (%)	N/A
N/A	Painted X Walk1?	No	N/A	Painted X Walk2?	No
	X Walk 1 Direction	To NE		X Walk 2 Direction	To NW
N/A	X Walk 1 Width (in)	N/A	N/A	X Walk 2 Width (in)	N/A
	X Walk 1 Slope (%)	3.9		X Walk 2 Slope (%)	1.0
	X Walk 1 X Slope (%)	1.5		X Walk 2 X Slope (%)	2.8

N/A	Ramp inside XWalk1?	N/A	N/A	Ramp inside XWalk2?	N/A
	Road Slope (%)	0.3	N/A	Clear Space?	N/A
	Road X Slope (%)	2.9	N/A	Clear Space to XWalk (in)	N/A
N/A	Any Obstructions?	N/A	N/A	Storm Grate/Utility Hazard?	N/A
	Obstruction Type			Storm Grate/Utility Type	
		N/A			N/A
		Yes		Surface Condition? (G/P)	Good

**Remove & Replace Curb Ramp With Two New Directional Ramps or Equivalent.**

**R304.5.1**

**\$ 3200.00**
