Access Compliance Report

Public Rights-of-Way

(Curb Ramps)

Intersection ID: 9069	Main Street: HEIL_PL	Cross Street: MULBERRY_AV	Location: W
ADA ID: BB777B709311	Ramp Type: PerpDiag	Initial Pass/Fail: Fail	Overall Compliance: No
		Severity Score: 10

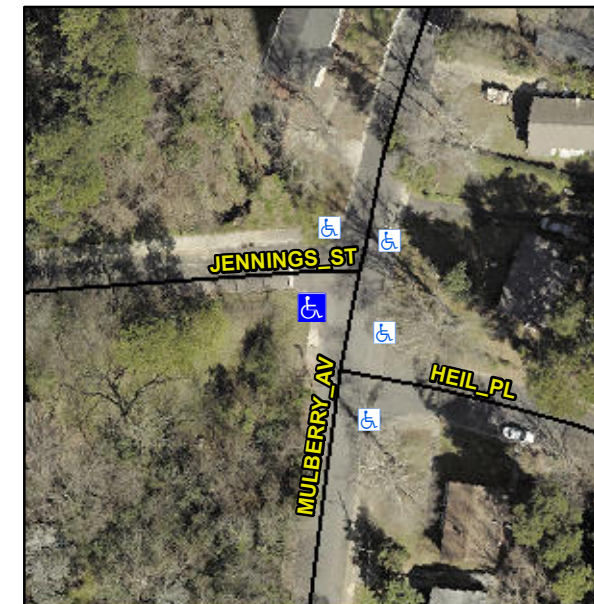
Not Found, R304.5.1, R304.5.3

Compliance	Description	Data	Compliance	Description	Data
N/A	Ramp Length (in)	61.0	Yes	Ramp Slope (%)	5.9
No	Ramp Width (in)	47.0	No	Ramp XSlope (%)	5.0
N/A	Flare Type LT	N/A	N/A	Flare Type RT	N/A
N/A	Flare Slope LT (%)	N/A	N/A	Flare Slope RT (%)	N/A
N/A	Flare Traversable LT?	N/A	N/A	Flare Traversable RT?	N/A
N/A	Landing Length (in)	N/A	N/A	DWS Provided?	N/A
N/A	Landing Width (in)	N/A	N/A	DWS Contrast?	N/A
N/A	Landing Slope (%)	N/A	N/A	DWS Length (in)	N/A
N/A	Landing X Slope (%)	N/A	N/A	DWS Full Width?	N/A
N/A	Landing Curb? (Y/N)	N/A	N/A	DWS Offset (in)	N/A
N/A	Shared Landing?	N/A			
N/A	Gutter Ponding?	N/A	N/A	Gutter Slope (%)	N/A
N/A	Gutter Lip Ht (in)	N/A	N/A	Gutter X Slope (%)	N/A
N/A	Painted X Walk1?	No	N/A	Painted X Walk2?	No
	X Walk 1 Direction	To NE		X Walk 2 Direction	To SE
N/A	X Walk 1 Width (in)	N/A	N/A	X Walk 2 Width (in)	N/A
	X Walk 1 Slope (%)	4.2		X Walk 2 Slope (%)	5.9
	X Walk 1 X Slope (%)	4.5		X Walk 2 X Slope (%)	1.7

N/A	Ramp inside XWalk1?	N/A	N/A	Ramp inside XWalk2?	N/A
	Road Slope (%)	2.9	N/A	Clear Space?	N/A
	Road X Slope (%)	3.5	N/A	Clear Space to XWalk (in)	N/A
N/A	Any Obstructions?	N/A	N/A	Storm Grate/Utility Hazard?	N/A
	Obstruction Type			Storm Grate/Utility Type	
		N/A			N/A
		Yes		Surface Condition? (G/P)	Good

Remove & Replace Curb Ramp With Two New Directional Ramps or Equivalent.
