# Access Compliance Report

## Public Rights-of-Way

### (Curb Ramps)

Intersection ID: 9408	Main Street: E_SUGAR_CREEK_RD	Cross Street: RALEIGH_ST	Location:	N
ADA ID: BB79558EC3F9	Ramp Type: Perp	Initial Pass/Fail: Fail	Overall Compliance: No	Severity Score: 12.5
Codes/Mitigation Info/Possible Solution		Field Measurements/Component Compliance

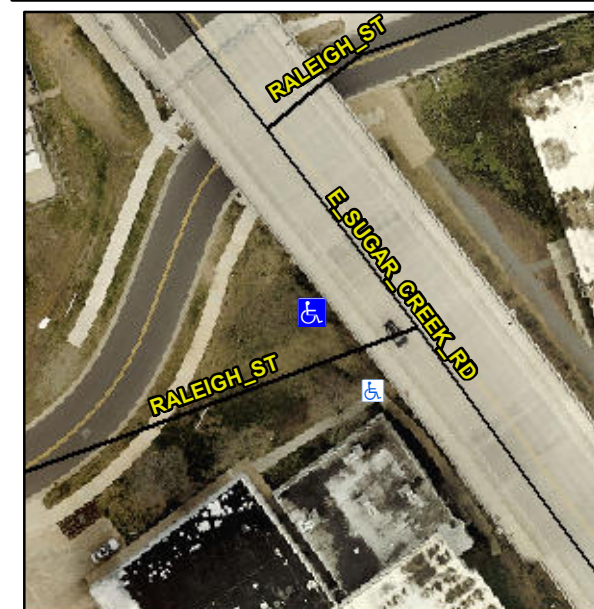
Compliance	Description	Data	Compliance	Description	Data
N/A	Ramp Length (in)	95.0	No	Ramp Slope (%)	8.8
Yes	Ramp Width (in)	83.0	Yes	Ramp XSlope (%)	0.3
N/A	Flare Type LT	N/A	N/A	Flare Type RT	N/A
N/A	Flare Slope LT (%)	N/A	N/A	Flare Slope RT (%)	N/A
N/A	Flare Traversable LT?	N/A	N/A	Flare Traversable RT?	N/A
N/A	Landing Length (in)	N/A	N/A	DWS Provided?	N/A
N/A	Landing Width (in)	N/A	N/A	DWS Contrast?	N/A
N/A	Landing Slope (%)	N/A	N/A	DWS Length (in)	N/A
N/A	Landing X Slope (%)	N/A	N/A	DWS Full Width?	N/A
N/A	Landing Curb? (Y/N)	N/A	N/A	DWS Offset (in)	N/A
N/A	Shared Landing?	N/A			
N/A	Gutter Ponding?	N/A	N/A	Gutter Slope (%)	N/A
N/A	Gutter Lip Ht (in)	N/A	N/A	Gutter X Slope (%)	N/A
N/A	Painted X Walk1?	No	N/A	Painted X Walk2?	N/A
	X Walk 1 Direction	To S		X Walk 2 Direction	N/A
N/A	X Walk 1 Width (in)	N/A	N/A	X Walk 2 Width (in)	N/A
	X Walk 1 Slope (%)	1.2		X Walk 2 Slope (%)	N/A
	X Walk 1 X Slope (%)	0.7		X Walk 2 X Slope (%)	N/A

N/A	Ramp inside XWalk1?	N/A	N/A	Ramp inside XWalk2?	N/A
	Road Slope (%)	N/A	N/A	Clear Space?	N/A
	Road X Slope (%)	N/A	N/A	Clear Space to XWalk (in)	N/A
N/A	Any Obstructions?	N/A	N/A	Storm Grate/Utility Hazard?	N/A
	Obstruction Type			Storm Grate/Utility Type	
		N/A			N/A
			Yes	Surface Condition? (G/P)	Good

Possible Solutions:

**Remove & Replace Entire Ramp.**

**R304.2.2**

**\$ 1850.00**
